Access Compliance Report Public Rights-of-Way (Curb Ramps)

Intersection ID: 18408 Main Street: REDCOAT DR Cross Street: LYNBROOK_DR Location: SE ADA ID: 48086EFFC9FD Ramp Type: PerpDiag Initial Pass/Fail: Fail **Overall Compliance: No** Severity Score: 13.75

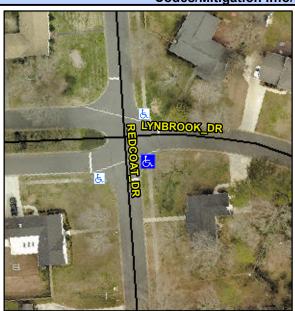
Field Measurements/Component Compliance								
	Compliance Description		Data	Comp	liance Description	Data		
	N/A	Ramp Length (in)	30.0	No	Ramp Slope (%)	9.9		
	Yes	Ramp Width (in)	48.0	No	Ramp XSlope (%)	2.5		
	N/A	Flare Type LT	N/A	N/A	Flare Type RT	N/A		
	N/A	Flare Slope LT (%)	N/A	N/A	Flare Slope RT (%)	N/A		
	N/A	Flare Traversable LT?	N/A	N/A	Flare Traversable RT?	N/A		
	N/A	Landing Length (in)	N/A	N/A	DWS Provided?	N/A		
	N/A	Landing Width (in)	N/A	N/A	DWS Contrast?	N/A		
	N/A	Landing Slope (%)	N/A	N/A	DWS Length (in)	N/A		
	N/A	Landing X Slope (%)	N/A	N/A	DWS Full Width?	N/A		
	N/A	Landing Curb? (Y/N)	N/A	N/A	DWS Offset (in)	N/A		
	N/A	Shared Landing?	N/A					
	N/A	Gutter Ponding?	N/A	N/A	Gutter Slope (%)	N/A		
	N/A	Gutter Lip Ht (in)	N/A	N/A	Gutter X Slope (%)	N/A		
	N/A	Painted X Walk1?	No	N/A	Painted X Walk2?	No		
		X Walk 1 Direction	To N		X Walk 2 Direction	To W		
	N/A	X Walk 1 Width (in)	N/A	N/A	X Walk 2 Width (in)	N/A

X Walk 1 Slope (%)	5.9		X Walk 2 Slope (%)	1.8		
		X Walk 1 X Slope (%)	2.5		X Walk 2 X Slope (%)	2.8		
	N/A	Ramp inside XWalk1?	N/A	N/A	Ramp inside XWalk2?	N/A		
		Road Slope (%)	0.3	N/A	Clear Space?	N/A		
		Road X Slope (%)	6.0	N/A	Clear Space to XWalk (in)	N/A		
	N/A	Any Obstructions?	N/A	N/A	Storm Grate/Utility Hazard?	N/A		
		Obstruction Type			Storm Grate/Utility Type			
			N/A			N/A		
				Yes	Surface Condition? (G/P)	Good

Pussible solution	
Possible Solutions:	
Remove & Replace Curb Ramp With Two New Directional Ramps or Equivalent.	
Surveyor Notes:	
N/A	
PROW/ADA:	
Not Found, R304.2.2, R304.5.3	!
	I
