# Access Compliance Report

## Public Rights-of-Way

### (Curb Ramps)

Intersection ID: 19805	Main Street: MORRISON_BV	Cross Street: SOUTH_PARK_DR	Location: SE
ADA ID: 480973BB7866	Ramp Type: Perp	Initial Pass/Fail: Fail	Overall Compliance: No
Severity Score: 33.75			
Codes/Mitigation Info/Possible Solution		Field Measurements/Component Compliance

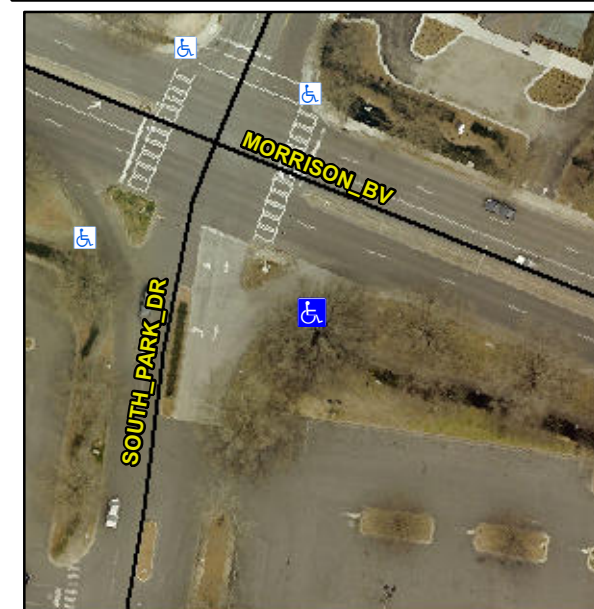
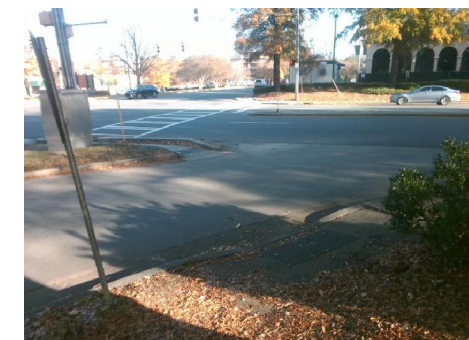
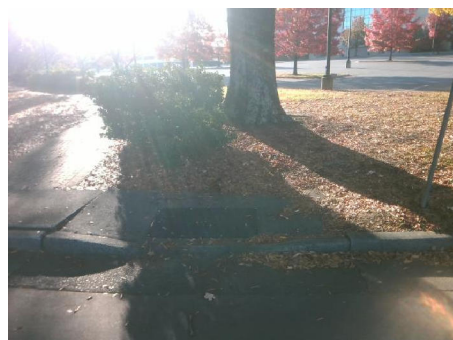
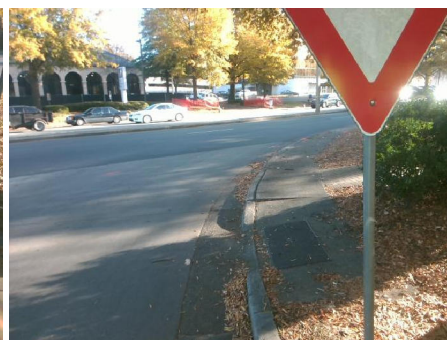
**Not Found, R304.5.1, R304.2.2**

Compliance	Description	Data	Compliance	Description	Data
N/A	Ramp Length (in)	51.0	No	Ramp Slope (%)	17.9
No	Ramp Width (in)	46.0	Yes	Ramp XSlope (%)	1.7
N/A	Flare Type LT	N/A	N/A	Flare Type RT	N/A
N/A	Flare Slope LT (%)	N/A	N/A	Flare Slope RT (%)	N/A
N/A	Flare Traversable LT?	N/A	N/A	Flare Traversable RT?	N/A
N/A	Landing Length (in)	N/A	N/A	DWS Provided?	N/A
N/A	Landing Width (in)	N/A	N/A	DWS Contrast?	N/A
N/A	Landing Slope (%)	N/A	N/A	DWS Length (in)	N/A
N/A	Landing X Slope (%)	N/A	N/A	DWS Full Width?	N/A
N/A	Landing Curb? (Y/N)	N/A	N/A	DWS Offset (in)	N/A
N/A	Shared Landing?	N/A			
N/A	Gutter Ponding?	N/A	N/A	Gutter Slope (%)	N/A
N/A	Gutter Lip Ht (in)	N/A	N/A	Gutter X Slope (%)	N/A
N/A	Painted X Walk1?	No	N/A	Painted X Walk2?	N/A
	X Walk 1 Direction	To NW		X Walk 2 Direction	N/A
N/A	X Walk 1 Width (in)	N/A	N/A	X Walk 2 Width (in)	N/A
	X Walk 1 Slope (%)	0.2		X Walk 2 Slope (%)	N/A
	X Walk 1 X Slope (%)	0.2		X Walk 2 X Slope (%)	N/A

N/A	Ramp inside XWalk1?	N/A	N/A	Ramp inside XWalk2?	N/A
	Road Slope (%)	N/A	N/A	Clear Space?	N/A
	Road X Slope (%)	N/A	N/A	Clear Space to XWalk (in)	N/A
N/A	Any Obstructions?	N/A	N/A	Storm Grate/Utility Hazard?	N/A
	Obstruction Type			Storm Grate/Utility Type	
		N/A			N/A
		Yes		Surface Condition? (G/P)	Good

**Remove & Replace Entire Ramp.**

Total Cost: \$ 1850.00
