Access Compliance Report Public Rights-of-Way (Curb Ramps)

Intersection ID: 7582 Main Street: AMBLE_DR Cross Street: N_GRAHAM_ST Location: E

ADA ID: 481CD0D8D3A8 Ramp Type: Perp Initial Pass/Fail: Fail Overall Compliance: No Severity Score: 21.25

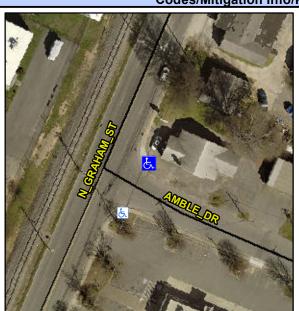
Field Measurements/Component Compliance						
		Data	Compliance Description		Data	
N/A	Ramp Length (in)	60.0	No	Ramp Slope (%)	9.9	
No	Ramp Width (in)	46.0	Yes	Ramp XSlope (%)	0.1	
N/A	Flare Type LT	N/A	N/A	Flare Type RT	N/A	
N/A	Flare Slope LT (%)	N/A	N/A	Flare Slope RT (%)	N/A	
N/A	Flare Traversable LT?	N/A	N/A	Flare Traversable RT?	N/A	
N/A	Landing Length (in)	N/A	N/A	DWS Provided?	N/A	
N/A	Landing Width (in)	N/A	N/A	DWS Contrast?	N/A	
N/A	Landing Slope (%)	N/A	N/A	DWS Length (in)	N/A	
N/A	Landing X Slope (%)	N/A	N/A	DWS Full Width?	N/A	
N/A	Landing Curb? (Y/N)	N/A	N/A	DWS Offset (in)	N/A	
N/A	Shared Landing?	N/A				
N/A	Gutter Ponding?	N/A	N/A	Gutter Slope (%)	N/A	
N/A	Gutter Lip Ht (in)	N/A	N/A	Gutter X Slope (%)	N/A	
N/A	Painted X Walk1?	No	N/A	Painted X Walk2?	N/A	
	X Walk 1 Direction	To SW		X Walk 2 Direction	N/A	
N/A	X Walk 1 Width (in)	N/A	N/A	X Walk 2 Width (in)	N/A	
	X Walk 1 Slope (%)	2.1		X Walk 2 Slope (%)	N/A

X Walk 1 X Slope (%)	2.9		X Walk 2 X Slope (%)	N/A	
N/A	Ramp inside XWalk1?	N/A	N/A	Ramp inside XWalk2?	N/A	
	Road Slope (%)	N/A	N/A	Clear Space?	N/A	
	Road X Slope (%)	N/A	N/A	Clear Space to XWalk (in)	N/A	
N/A	Any Obstructions?	N/A	N/A	Storm Grate/Utility Hazard?	N/A	
	Obstruction Type			Storm Grate/Utility Type		
		N/A			N/A	
			Yes	Surface Condition? (G/P)	Good

Possible Solutions:					
Remove & Replace Entire Ramp.					
·					
Surveyor Notes:					
N/A					
WA .					
PROW/ADA:					
Not Found, R304.5.1, R304.2.2					
Not Found, K304.5.1, K304.2.2
