Access Compliance Report

Public Rights-of-Way

(Curb Ramps)

Intersection ID: 29647	Main Street: BALLYSHANNON_LN	Cross Street: SOUTHERN_GARDEN_LN	Location: SE
ADA ID: 4826FDC5E217	Ramp Type: BlendTrans1	Initial Pass/Fail: Fail	Overall Compliance: No
		Severity Score: 18.75

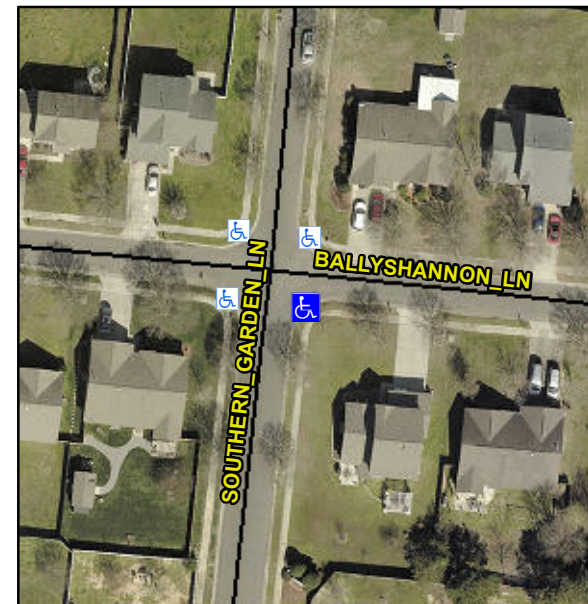
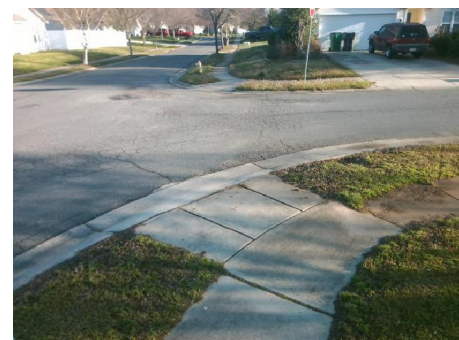
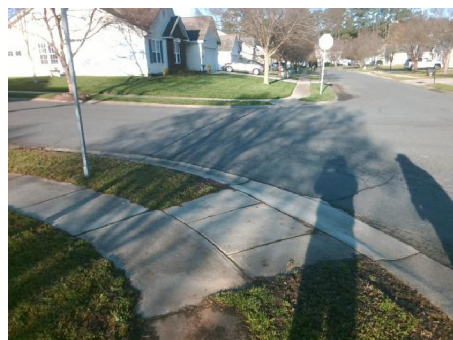
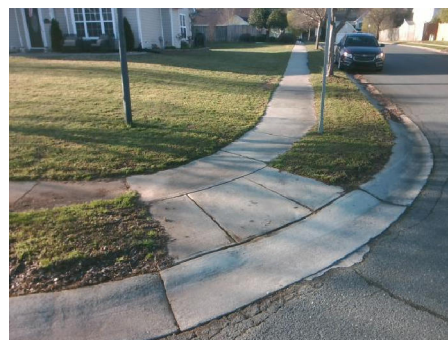
Not Found, R304.5.1, R304.5.3

Compliance	Description	Data	Compliance	Description	Data
N/A	Ramp Length (in)	46.5	Yes	BlendTrans Slope (%)	4.8
No	Ramp Width (in)	33.0	No	BlendTrans XSlope (%)	3.9
N/A	Flare Type LT	N/A	N/A	Flare Type RT	N/A
N/A	Flare Slope LT (%)	N/A	N/A	Flare Slope RT (%)	N/A
N/A	Flare Traversable LT?	N/A	N/A	Flare Traversable RT?	N/A
N/A	Landing Length (in)	N/A	N/A	DWS Provided?	N/A
N/A	Landing Width (in)	N/A	N/A	DWS Contrast?	N/A
N/A	Landing Slope (%)	N/A	N/A	DWS Length (in)	N/A
N/A	Landing X Slope (%)	N/A	N/A	DWS Full Width?	N/A
N/A	Landing Curb? (Y/N)	N/A	N/A	DWS Offset (in)	N/A
N/A	Shared Landing?	N/A			
N/A	Gutter Ponding?	N/A	N/A	Gutter Slope (%)	N/A
N/A	Gutter Lip Ht (in)	N/A	N/A	Gutter X Slope (%)	N/A
N/A	Painted X Walk1?	No	N/A	Painted X Walk2?	No
	X Walk 1 Direction	To N		X Walk 2 Direction	To W
	X Walk 1 Width (in)	N/A		X Walk 2 Width (in)	N/A
	X Walk 1 Slope (%)	2.4		X Walk 2 Slope (%)	0.8
	X Walk 1 X Slope (%)	1.2		X Walk 2 X Slope (%)	3.2

N/A	Ramp inside XWalk1?	N/A	N/A	Ramp inside XWalk2?	N/A
	Road Slope (%)	2.4		Clear Space?	N/A
	Road X Slope (%)	1.0	N/A	Clear Space to XWalk (in)	N/A
N/A	Any Obstructions?	N/A	N/A	Storm Grate/Utility Hazard?	N/A
	Obstruction Type			Storm Grate/Utility Type	
		N/A			N/A
			Yes	Surface Condition? (G/P)	Good
			No	Curb Slope (%)	7.8

Remove & Replace Curb Ramp With Two New Directional Ramps or Equivalent.
