# Access Compliance Report

## Public Rights-of-Way

### (Curb Ramps)

Intersection ID: 53713	Main Street: N_TRYON_ST	Cross Street: PERIWINKLE_HILL_AV	Location: S
ADA ID: 483AA59DA00B	Ramp Type: BlendTrans1	Initial Pass/Fail: Fail	Overall Compliance: No
		Severity Score: 8.75

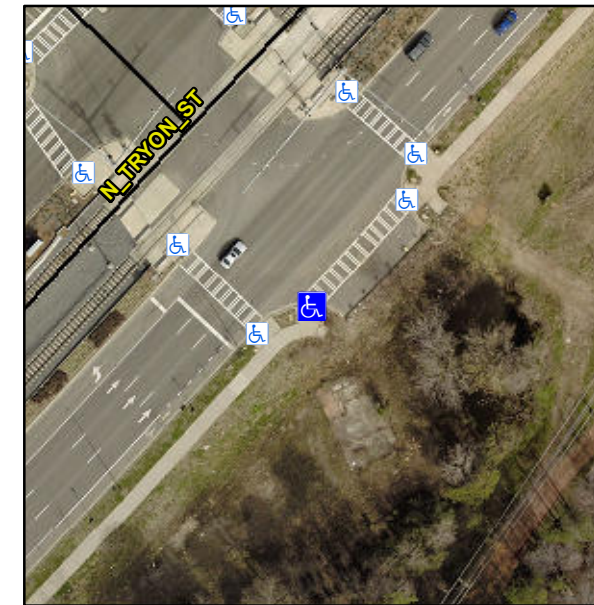
**Not Found, R304.5.1**

Compliance	Description	Data	Compliance	Description	Data
N/A	Ramp Length (in)	96.0	Yes	BlendTrans Slope (%)	3.6
No	Ramp Width (in)	44.0	Yes	BlendTrans XSlope (%)	1.2
N/A	Flare Type LT	N/A	N/A	Flare Type RT	N/A
N/A	Flare Slope LT (%)	N/A	N/A	Flare Slope RT (%)	N/A
N/A	Flare Traversable LT?	N/A	N/A	Flare Traversable RT?	N/A
N/A	Landing Length (in)	N/A	N/A	DWS Provided?	N/A
N/A	Landing Width (in)	N/A	N/A	DWS Contrast?	N/A
N/A	Landing Slope (%)	N/A	N/A	DWS Length (in)	N/A
N/A	Landing X Slope (%)	N/A	N/A	DWS Full Width?	N/A
N/A	Landing Curb? (Y/N)	N/A	N/A	DWS Offset (in)	N/A
N/A	Shared Landing?	N/A			
N/A	Gutter Ponding?	N/A	N/A	Gutter Slope (%)	N/A
N/A	Gutter Lip Ht (in)	N/A	N/A	Gutter X Slope (%)	N/A
N/A	Painted X Walk1?	Yes	N/A	Painted X Walk2?	N/A
	X Walk 1 Direction	To NE		X Walk 2 Direction	N/A
	X Walk 1 Width (in)	113.0		X Walk 2 Width (in)	N/A
	X Walk 1 Slope (%)	0.8		X Walk 2 Slope (%)	N/A
	X Walk 1 X Slope (%)	3.8		X Walk 2 X Slope (%)	N/A

N/A	Ramp inside XWalk1?	Yes	N/A	Ramp inside XWalk2?	N/A
	Road Slope (%)	3.8		Clear Space?	N/A
	Road X Slope (%)	0.8	N/A	Clear Space to XWalk (in)	N/A
N/A	Any Obstructions?	N/A	N/A	Storm Grate/Utility Hazard?	N/A
	Obstruction Type			Storm Grate/Utility Type	
		N/A			N/A
			Yes	Surface Condition? (G/P)	Good
			No	Curb Slope (%)	7.5

**Remove & Replace Curb Ramp With Two New Directional Ramps or Equivalent.**
