Access Compliance Report

Public Rights-of-Way

(Curb Ramps)

Intersection ID: 10053	Main Street: BURTON_ST	Cross Street: FONTANA_AV	Location: NE
ADA ID: 483AF97ABE76	Ramp Type: Perp	Initial Pass/Fail: Fail	Overall Compliance: No
Severity Score: 12.5			
Codes/Mitigation Info/Possible Solution		Field Measurements/Component Compliance

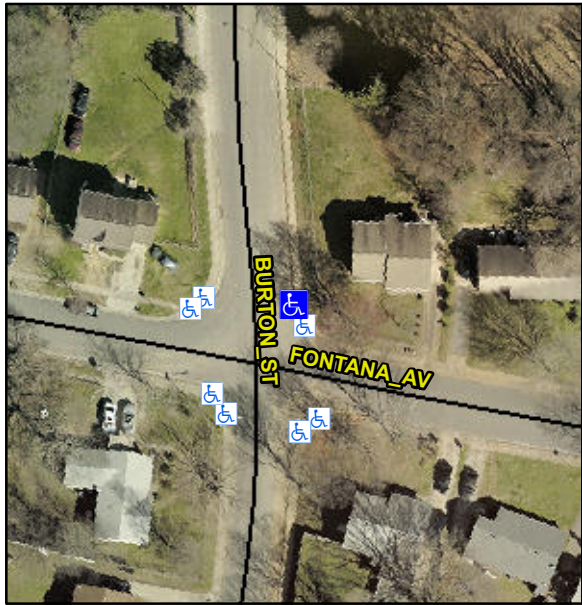
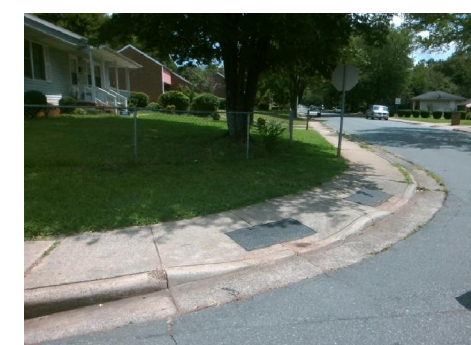
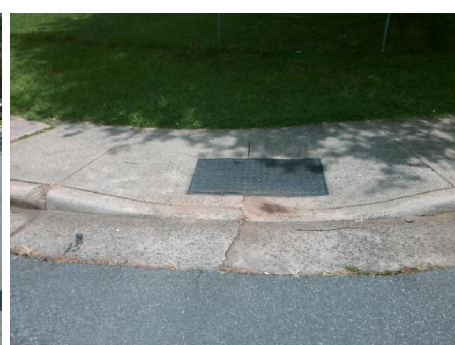
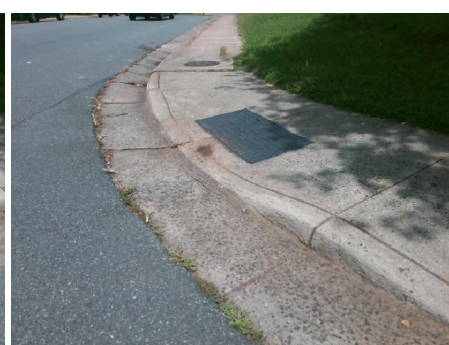
Compliance	Description	Data	Compliance	Description	Data
N/A	Ramp Length (in)	60.5	No	Ramp Slope (%)	9.9
Yes	Ramp Width (in)	48.0	Yes	Ramp XSlope (%)	1.3
N/A	Flare Type LT	N/A	N/A	Flare Type RT	N/A
N/A	Flare Slope LT (%)	N/A	N/A	Flare Slope RT (%)	N/A
N/A	Flare Traversable LT?	N/A	N/A	Flare Traversable RT?	N/A
N/A	Landing Length (in)	N/A	N/A	DWS Provided?	N/A
N/A	Landing Width (in)	N/A	N/A	DWS Contrast?	N/A
N/A	Landing Slope (%)	N/A	N/A	DWS Length (in)	N/A
N/A	Landing X Slope (%)	N/A	N/A	DWS Full Width?	N/A
N/A	Landing Curb? (Y/N)	N/A	N/A	DWS Offset (in)	N/A
N/A	Shared Landing?	N/A			
N/A	Gutter Ponding?	N/A	N/A	Gutter Slope (%)	N/A
N/A	Gutter Lip Ht (in)	1.0	N/A	Gutter X Slope (%)	N/A
N/A	Painted X Walk1?	No	N/A	Painted X Walk2?	N/A
	X Walk 1 Direction	To NW		X Walk 2 Direction	N/A
N/A	X Walk 1 Width (in)	N/A	N/A	X Walk 2 Width (in)	N/A
	X Walk 1 Slope (%)	2.7		X Walk 2 Slope (%)	N/A
	X Walk 1 X Slope (%)	0.8		X Walk 2 X Slope (%)	N/A

N/A	Ramp inside XWalk1?	N/A	N/A	Ramp inside XWalk2?	N/A
	Road Slope (%)	N/A	N/A	Clear Space?	N/A
	Road X Slope (%)	N/A	N/A	Clear Space to XWalk (in)	N/A
N/A	Any Obstructions?	N/A	N/A	Storm Grate/Utility Hazard?	N/A
	Obstruction Type			Storm Grate/Utility Type	
		N/A			N/A
			Yes	Surface Condition? (G/P)	Good

Possible Solutions:

Remove & Replace Entire Ramp.
