Access Compliance Report

Public Rights-of-Way

(Curb Ramps)

Intersection ID: 44701	Main Street: MARY_BLAIR_LN	Cross Street: EAGLES_LANDING_DR	Location: SE
ADA ID: 483EA6E65494	Ramp Type: Perp	Initial Pass/Fail: Fail	Overall Compliance: No
Severity Score: 21.25			
Codes/Mitigation Info/Possible Solution		Field Measurements/Component Compliance

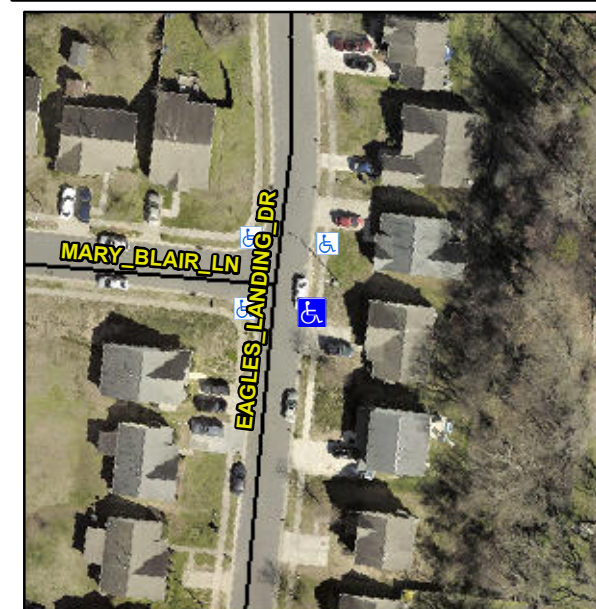
Not Found, R304.5.1, R304.5.3

Compliance	Description	Data	Compliance	Description	Data
N/A	Ramp Length (in)	48.0	Yes	Ramp Slope (%)	5.8
No	Ramp Width (in)	46.0	No	Ramp XSlope (%)	6.3
N/A	Flare Type LT	N/A	N/A	Flare Type RT	N/A
N/A	Flare Slope LT (%)	N/A	N/A	Flare Slope RT (%)	N/A
N/A	Flare Traversable LT?	N/A	N/A	Flare Traversable RT?	N/A
N/A	Landing Length (in)	N/A	N/A	DWS Provided?	N/A
N/A	Landing Width (in)	N/A	N/A	DWS Contrast?	N/A
N/A	Landing Slope (%)	N/A	N/A	DWS Length (in)	N/A
N/A	Landing X Slope (%)	N/A	N/A	DWS Full Width?	N/A
N/A	Landing Curb? (Y/N)	N/A	N/A	DWS Offset (in)	N/A
N/A	Shared Landing?	N/A			
N/A	Gutter Ponding?	N/A	N/A	Gutter Slope (%)	N/A
N/A	Gutter Lip Ht (in)	N/A	N/A	Gutter X Slope (%)	N/A
N/A	Painted X Walk1?	No	N/A	Painted X Walk2?	N/A
	X Walk 1 Direction	To W		X Walk 2 Direction	N/A
N/A	X Walk 1 Width (in)	N/A	N/A	X Walk 2 Width (in)	N/A
	X Walk 1 Slope (%)	4.2		X Walk 2 Slope (%)	N/A
	X Walk 1 X Slope (%)	5.1		X Walk 2 X Slope (%)	N/A

N/A	Ramp inside XWalk1?	N/A	N/A	Ramp inside XWalk2?	N/A
	Road Slope (%)	N/A	N/A	Clear Space?	N/A
	Road X Slope (%)	N/A	N/A	Clear Space to XWalk (in)	N/A
N/A	Any Obstructions?	N/A	N/A	Storm Grate/Utility Hazard?	N/A
	Obstruction Type			Storm Grate/Utility Type	
		N/A			N/A
			Yes	Surface Condition? (G/P)	Good

Possible Solutions:

Remove & Replace Entire Ramp.
