# Access Compliance Report

## Public Rights-of-Way

### (Curb Ramps)

Intersection ID: 27584	Main Street: ELM_LN	Cross Street: WILLIAMS_POND_LN	Location: SE
ADA ID: 48407EB7A6B5	Ramp Type: Perp	Initial Pass/Fail: Fail	Overall Compliance: No
Severity Score: 12.5			
Codes/Mitigation Info/Possible Solution		Field Measurements/Component Compliance

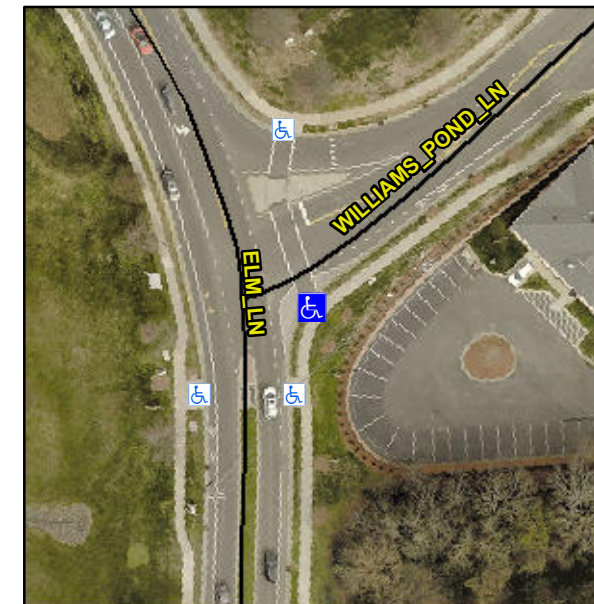
**Not Found, R304.2.2**

Compliance	Description	Data	Compliance	Description	Data
N/A	Ramp Length (in)	79.0	No	Ramp Slope (%)	8.5
Yes	Ramp Width (in)	48.0	Yes	Ramp XSlope (%)	0.2
N/A	Flare Type LT	N/A	N/A	Flare Type RT	N/A
N/A	Flare Slope LT (%)	N/A	N/A	Flare Slope RT (%)	N/A
N/A	Flare Traversable LT?	N/A	N/A	Flare Traversable RT?	N/A
N/A	Landing Length (in)	N/A	N/A	DWS Provided?	N/A
N/A	Landing Width (in)	N/A	N/A	DWS Contrast?	N/A
N/A	Landing Slope (%)	N/A	N/A	DWS Length (in)	N/A
N/A	Landing X Slope (%)	N/A	N/A	DWS Full Width?	N/A
N/A	Landing Curb? (Y/N)	N/A	N/A	DWS Offset (in)	N/A
N/A	Shared Landing?	N/A			
N/A	Gutter Ponding?	N/A	N/A	Gutter Slope (%)	N/A
N/A	Gutter Lip Ht (in)	N/A	N/A	Gutter X Slope (%)	N/A
N/A	Painted X Walk1?	Yes	N/A	Painted X Walk2?	N/A
	X Walk 1 Direction	To NE		X Walk 2 Direction	N/A
N/A	X Walk 1 Width (in)	112.0	N/A	X Walk 2 Width (in)	N/A
	X Walk 1 Slope (%)	1.3		X Walk 2 Slope (%)	N/A
	X Walk 1 X Slope (%)	0.7		X Walk 2 X Slope (%)	N/A

N/A	Ramp inside XWalk1?	Yes	N/A	Ramp inside XWalk2?	N/A
	Road Slope (%)	N/A	N/A	Clear Space?	N/A
	Road X Slope (%)	N/A	N/A	Clear Space to XWalk (in)	N/A
N/A	Any Obstructions?	N/A	N/A	Storm Grate/Utility Hazard?	N/A
	Obstruction Type			Storm Grate/Utility Type	
		N/A			N/A
			Yes	Surface Condition? (G/P)	Good

Possible Solutions:

**Remove & Replace Entire Ramp.**

Total Cost: \$ 1850.00
