Access Compliance Report

Public Rights-of-Way

(Curb Ramps)

Intersection ID: 24385	Main Street: BEVERLY_CREST_BV	Cross Street: BECKMORE_PL	Location: SW
ADA ID: 4855FD367D86	Ramp Type: Perp	Initial Pass/Fail: Fail	Overall Compliance: No
		Severity Score: 12.5

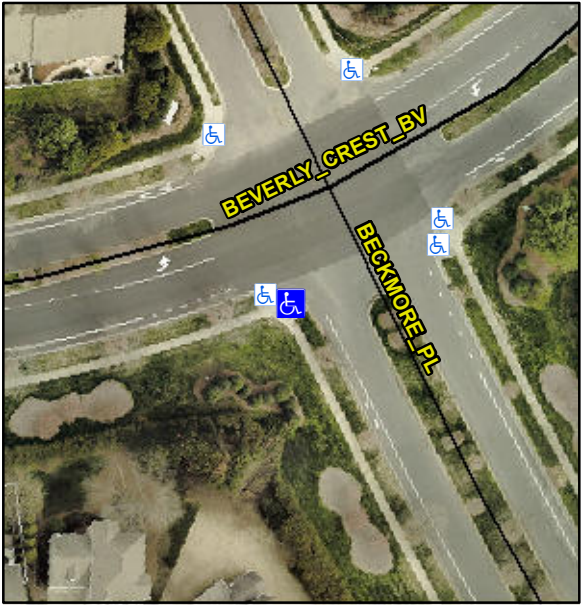
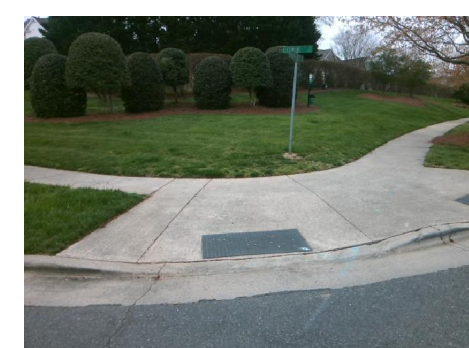
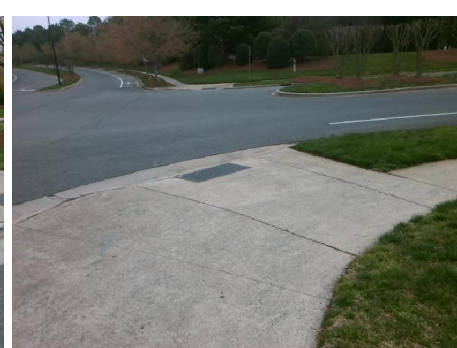
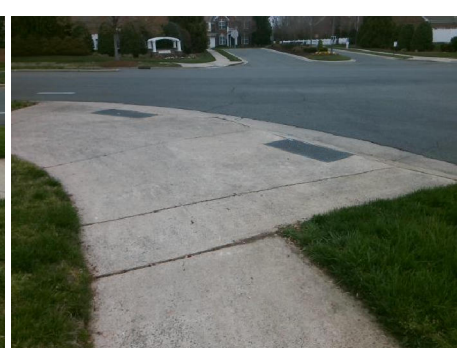
Possible Solutions:		Compliance	Description	Data
	Remove & Replace Entire Ramp.		No	Ramp Length (in)	96.0
			Yes	Ramp Width (in)	80.0
			N/A	Flare Type LT	N/A
			N/A	Flare Slope LT (%)	N/A
			N/A	Flare Traversable LT?	N/A
			N/A	Landing Length (in)	N/A
			N/A	Landing Width (in)	N/A
			N/A	Landing Slope (%)	N/A
			N/A	Landing X Slope (%)	N/A
<p>Surveyor Notes:</p> <p>N/A</p> <p>PROW/ADA:</p> <p>Not Found, R304.2.2</p>			N/A	Flare Type RT	N/A
			N/A	Flare Slope RT (%)	N/A
			N/A	Flare Traversable RT?	N/A
			N/A	DWS Provided?	N/A
			N/A	DWS Contrast?	N/A
			N/A	DWS Length (in)	N/A
			N/A	DWS Full Width?	N/A
			N/A	DWS Offset (in)	N/A
			N/A	Shared Landing?	N/A
			N/A	Gutter Ponding?	N/A
			N/A	Gutter Lip Ht (in)	N/A
			N/A	Painted X Walk1?	No
				X Walk 1 Direction	To E
			N/A	X Walk 1 Width (in)	N/A
				X Walk 1 Slope (%)	1.8
				X Walk 1 X Slope (%)	1.2

N/A	Ramp inside XWalk1?	N/A
			N/A	Road Slope (%)	N/A
			N/A	Road X Slope (%)	N/A
			N/A	Any Obstructions?	N/A
				Obstruction Type	
			N/A		
			N/A		
			N/A		
			N/A		
			N/A		
			N/A		
			N/A		
			N/A		
			N/A		
Total Cost:			\$	1850.00	
Street 1 Name	BECKMORE PL				
Stop Condition-Street 2	StopSign				
Street 2 Name	N/A				
Stop Condition-Street 1	N/A
