## Access Compliance Report Public Rights-of-Way (Curb Ramps)

Internetion ID: 07700 Main Street: DI AKENEY, USATU DD				Owner Official DOVANT FADMO DD				Lesstian	05	
Intersection ID: 27766	27766 Main Street: BLAKENEY_HEATH_RD			Cross Street: BRYANT_FARMS_RD				Location:	SE	
ADA ID: 485F03E273B6 Ramp Type: Perp			Initial	Initial Pass/Fail: Fail Overall Compliance: No				o Severity Score:	12.5	
Codes/Mitigation Info/Possible Solution				Field Measurements/Component Compliance						
		Possible Solutions:		Compliance Description			Data Compliance Description			
	strain a survey	Remove & Replace Entire Ram	).	N/A	Ramp Length (in)	37.0	No	Ramp Slope (%)	8.4	
8 mill s state	10-1-1			Yes	Ramp Width (in)	48.0	Yes	Ramp XSlope (%)	1.8	
				N/A	Flare Type LT	N/A	N/A	Flare Type RT	N/A	
				N/A	Flare Slope LT (%)	N/A	N/A	Flare Slope RT (%)	N/A	
	16			N/A	Flare Traversable LT?	N/A	N/A	Flare Traversable RT?	N/A	
				N/A	Landing Length (in)	N/A	N/A	DWS Provided?	N/A	
A A A A A A A A A A A A A A A A A A A	1 h	Surveyor Notes:		N/A	Landing Width (in)	N/A	N/A	DWS Contrast?	N/A

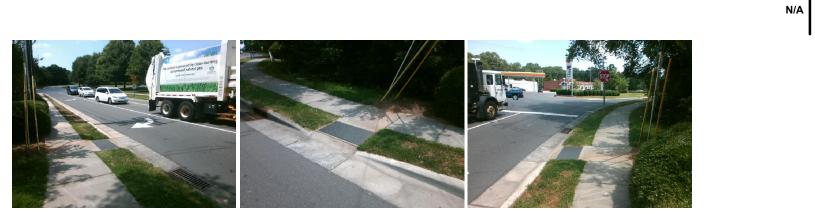
1.4				X Walk 1 Direction	To SW		X Walk 2 Direction	N/A	
				N/A	X Walk 1 Width (in)	N/A	N/A	X Walk 2 Width (in)	N/A	
Street 1 Name BLAKENEY H	IEATH RD	_			X Walk 1 Slope (%)	5.2		X Walk 2 Slope (%)	N/A	
Stop Condition-Street 2	StopSign				X Walk 1 X Slope (%)	2.6		X Walk 2 X Slope (%)	N/A	
Street 2 Name	N/A			N/A	Ramp inside XWalk1?	N/A	N/A	Ramp inside XWalk2?	N/A	
Stop Condition-Street 1	N/A				Road Slope (%)	N/A	N/A	Clear Space?	N/A	
					Road X Slope (%)	N/A	N/A	Clear Space to XWalk (in)	N/A	
				N/A	Any Obstructions?	N/A	N/A	Storm Grate/Utility Hazard?	N/A	
		Total Cost: \$	1850.00		Obstruction Type			Storm Grate/Utility Type		
						N/A			N/A
