# Access Compliance Report

## Public Rights-of-Way

### (Curb Ramps)

Intersection ID: 21910	Main Street: CARMEL_RD	Cross Street: COLONY_RD	Location: N
ADA ID: 4879808336EC	Ramp Type: PerpDiag	Initial Pass/Fail: Fail	Overall Compliance: No
Severity Score: 33.75			
Codes/Mitigation Info/Possible Solution		Field Measurements/Component Compliance

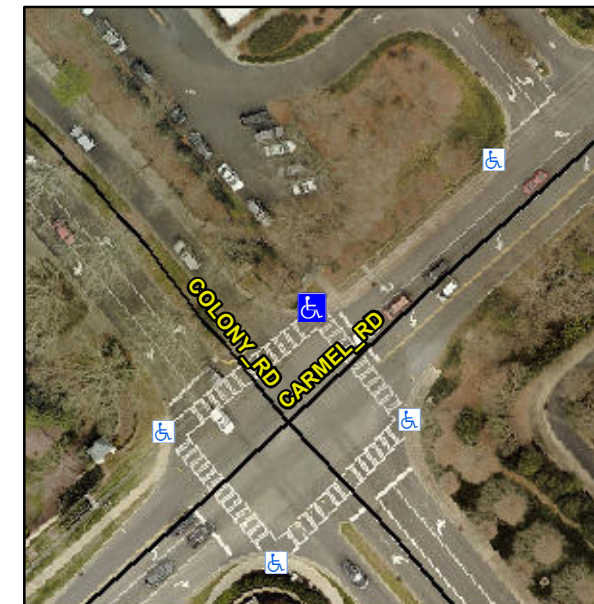
**Not Found, R304.5.1, R304.2.2**

Compliance	Description	Data	Compliance	Description	Data
N/A	Ramp Length (in)	60.0	No	Ramp Slope (%)	12.5
No	Ramp Width (in)	46.0	Yes	Ramp XSlope (%)	0.8
N/A	Flare Type LT	N/A	N/A	Flare Type RT	N/A
N/A	Flare Slope LT (%)	N/A	N/A	Flare Slope RT (%)	N/A
N/A	Flare Traversable LT?	N/A	N/A	Flare Traversable RT?	N/A
N/A	Landing Length (in)	N/A	N/A	DWS Provided?	N/A
N/A	Landing Width (in)	N/A	N/A	DWS Contrast?	N/A
N/A	Landing Slope (%)	N/A	N/A	DWS Length (in)	N/A
N/A	Landing X Slope (%)	N/A	N/A	DWS Full Width?	N/A
N/A	Landing Curb? (Y/N)	N/A	N/A	DWS Offset (in)	N/A
N/A	Shared Landing?	N/A			
N/A	Gutter Ponding?	N/A	N/A	Gutter Slope (%)	N/A
N/A	Gutter Lip Ht (in)	N/A	N/A	Gutter X Slope (%)	N/A
N/A	Painted X Walk1?	Yes	N/A	Painted X Walk2?	Yes
	X Walk 1 Direction	To SW		X Walk 2 Direction	To SE
N/A	X Walk 1 Width (in)	109.0	N/A	X Walk 2 Width (in)	101.0
	X Walk 1 Slope (%)	0.1		X Walk 2 Slope (%)	2.4
	X Walk 1 X Slope (%)	0.7		X Walk 2 X Slope (%)	0.2

N/A	Ramp inside XWalk1?	Yes	N/A	Ramp inside XWalk2?	Yes
	Road Slope (%)	0.2	N/A	Clear Space?	N/A
	Road X Slope (%)	2.2	N/A	Clear Space to XWalk (in)	N/A
N/A	Any Obstructions?	N/A	N/A	Storm Grate/Utility Hazard?	N/A
	Obstruction Type			Storm Grate/Utility Type	
		N/A			N/A
		Yes		Surface Condition? (G/P)	Good

**Remove & Replace Curb Ramp With Two New Directional Ramps or Equivalent.**

Total Cost: \$ 3200.00
