Access Compliance Report

Public Rights-of-Way

(Curb Ramps)

Intersection ID: 18614	Main Street: HUNTER_LN	Cross Street: RANDOLPH_RD	Location: NW
ADA ID: 487AC772B488	Ramp Type: Perp	Initial Pass/Fail: Fail	Overall Compliance: No
Codes/Mitigation Info/Possible Solution		Field Measurements/Component Compliance	
Severity Score: 12.5

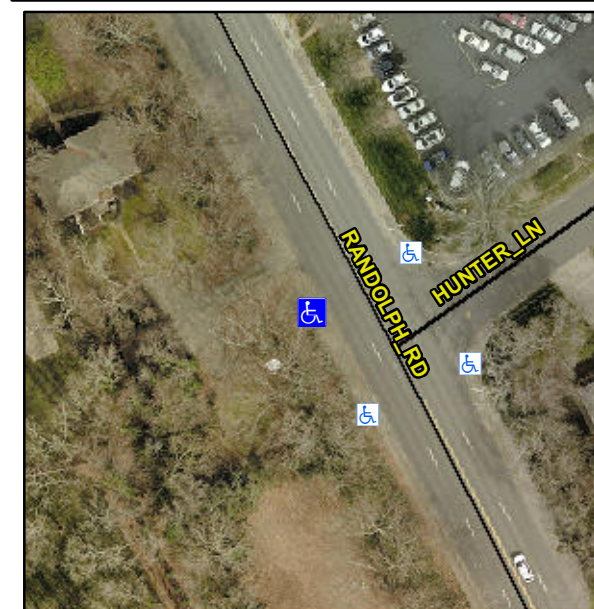
Not Found, R304.2.2

Compliance	Description	Data	Compliance	Description	Data
N/A	Ramp Length (in)	71.0	No	Ramp Slope (%)	10.7
Yes	Ramp Width (in)	48.0	Yes	Ramp XSlope (%)	0.1
N/A	Flare Type LT	N/A	N/A	Flare Type RT	N/A
N/A	Flare Slope LT (%)	N/A	N/A	Flare Slope RT (%)	N/A
N/A	Flare Traversable LT?	N/A	N/A	Flare Traversable RT?	N/A
N/A	Landing Length (in)	N/A	N/A	DWS Provided?	N/A
N/A	Landing Width (in)	N/A	N/A	DWS Contrast?	N/A
N/A	Landing Slope (%)	N/A	N/A	DWS Length (in)	N/A
N/A	Landing X Slope (%)	N/A	N/A	DWS Full Width?	N/A
N/A	Landing Curb? (Y/N)	N/A	N/A	DWS Offset (in)	N/A
N/A	Shared Landing?	N/A			
N/A	Gutter Ponding?	N/A	N/A	Gutter Slope (%)	N/A
N/A	Gutter Lip Ht (in)	N/A	N/A	Gutter X Slope (%)	N/A
N/A	Painted X Walk1?	No	N/A	Painted X Walk2?	N/A
	X Walk 1 Direction	To NE		X Walk 2 Direction	N/A
N/A	X Walk 1 Width (in)	N/A	N/A	X Walk 2 Width (in)	N/A
	X Walk 1 Slope (%)	4.0		X Walk 2 Slope (%)	N/A
	X Walk 1 X Slope (%)	0.4		X Walk 2 X Slope (%)	N/A

Remove & Replace Entire Ramp.
