Access Compliance Report

Public Rights-of-Way

(Curb Ramps)

Intersection ID: 45885	Main Street: ETHEL_CT	Cross Street: BEN_LIVINGSTON_RD	Location: W
ADA ID: 488B8C6FF419	Ramp Type: PerpDiag	Initial Pass/Fail: Fail	Overall Compliance: No
		Severity Score: 10

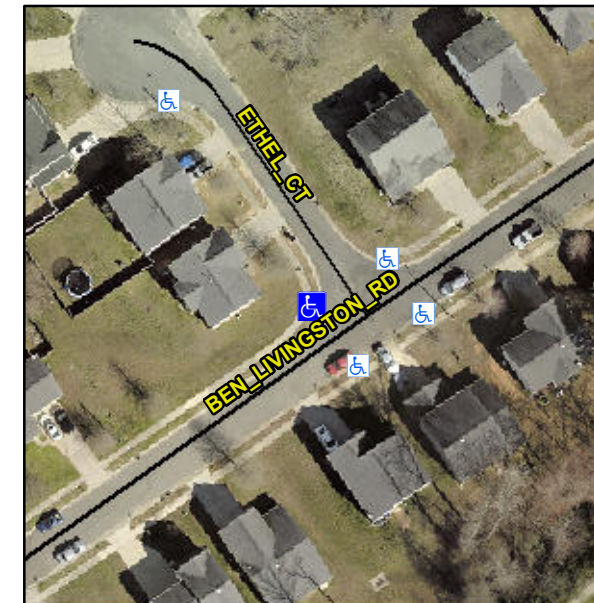
Compliance	Description	Data	Compliance	Description	Data
N/A	Ramp Length (in)	46.0	Yes	Ramp Slope (%)	7.7
No	Ramp Width (in)	45.0	No	Ramp XSlope (%)	2.5
N/A	Flare Type LT	N/A	N/A	Flare Type RT	N/A
N/A	Flare Slope LT (%)	N/A	N/A	Flare Slope RT (%)	N/A
N/A	Flare Traversable LT?	N/A	N/A	Flare Traversable RT?	N/A
N/A	Landing Length (in)	N/A	N/A	DWS Provided?	N/A
N/A	Landing Width (in)	N/A	N/A	DWS Contrast?	N/A
N/A	Landing Slope (%)	N/A	N/A	DWS Length (in)	N/A
N/A	Landing X Slope (%)	N/A	N/A	DWS Full Width?	N/A
N/A	Landing Curb? (Y/N)	N/A	N/A	DWS Offset (in)	N/A
N/A	Shared Landing?	N/A			
N/A	Gutter Ponding?	N/A	N/A	Gutter Slope (%)	N/A
N/A	Gutter Lip Ht (in)	N/A	N/A	Gutter X Slope (%)	N/A
N/A	Painted X Walk1?	No	N/A	Painted X Walk2?	No
	X Walk 1 Direction	To SE		X Walk 2 Direction	To NE
N/A	X Walk 1 Width (in)	N/A	N/A	X Walk 2 Width (in)	N/A
	X Walk 1 Slope (%)	4.0		X Walk 2 Slope (%)	4.2
	X Walk 1 X Slope (%)	4.9		X Walk 2 X Slope (%)	2.9

N/A	Ramp inside XWalk1?	N/A	N/A	Ramp inside XWalk2?	N/A
	Road Slope (%)	0.9	N/A	Clear Space?	N/A
	Road X Slope (%)	6.8	N/A	Clear Space to XWalk (in)	N/A
N/A	Any Obstructions?	N/A	N/A	Storm Grate/Utility Hazard?	N/A
	Obstruction Type			Storm Grate/Utility Type	
		N/A			N/A
			Yes	Surface Condition? (G/P)	Good

Possible Solutions:

Remove & Replace Curb Ramp With Two New Directional Ramps or Equivalent.

R304.5.1, R304.5.3
