# Access Compliance Report

## Public Rights-of-Way

Intersection ID: 51044	Main Street: KENDALL_DR	Cross Street: LONGNOR_ST	Location: SW
ADA ID: 488D1A88053D	Ramp Type: BlendTrans1	Initial Pass/Fail: Fail	Overall Compliance: No
Severity Score: 1.25			
Codes/Mitigation Info/Possible Solution		Field Measurements/Component Compliance

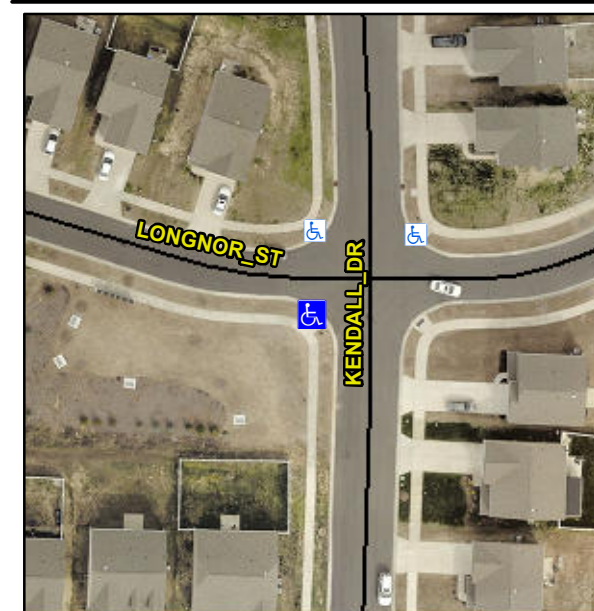
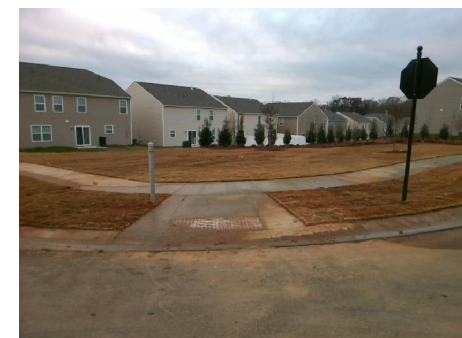
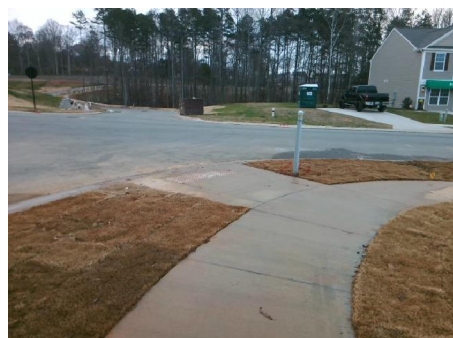
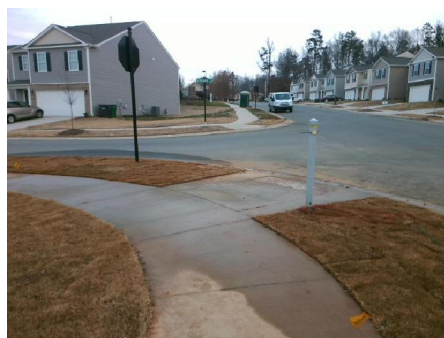
Compliance	Description	Data	Compliance	Description	Data
N/A	Ramp Length (in)	95.5	Yes	BlendTrans Slope (%)	2.3
Yes	Ramp Width (in)	54.0	No	BlendTrans XSlope (%)	2.7
N/A	Flare Type LT	N/A	N/A	Flare Type RT	N/A
N/A	Flare Slope LT (%)	N/A	N/A	Flare Slope RT (%)	N/A
N/A	Flare Traversable LT?	N/A	N/A	Flare Traversable RT?	N/A
N/A	Landing Length (in)	N/A	N/A	DWS Provided?	N/A
N/A	Landing Width (in)	N/A	N/A	DWS Contrast?	N/A
N/A	Landing Slope (%)	N/A	N/A	DWS Length (in)	N/A
N/A	Landing X Slope (%)	N/A	N/A	DWS Full Width?	N/A
N/A	Landing Curb? (Y/N)	N/A	N/A	DWS Offset (in)	N/A
N/A	Shared Landing?	N/A			
N/A	Gutter Ponding?	Yes	N/A	Gutter Slope (%)	N/A
N/A	Gutter Lip Ht (in)	N/A	N/A	Gutter X Slope (%)	N/A
N/A	Painted X Walk1?	No	N/A	Painted X Walk2?	No
	X Walk 1 Direction	To E		X Walk 2 Direction	To N
	X Walk 1 Width (in)	N/A		X Walk 2 Width (in)	N/A
	X Walk 1 Slope (%)	3.1		X Walk 2 Slope (%)	N/A
	X Walk 1 X Slope (%)	3.2		X Walk 2 X Slope (%)	N/A

N/A	Ramp inside XWalk1?	N/A	N/A	Ramp inside XWalk2?	N/A
	Road Slope (%)	3.2		Clear Space?	N/A
	Road X Slope (%)	3.1	N/A	Clear Space to XWalk (in)	N/A
N/A	Any Obstructions?	N/A	N/A	Storm Grate/Utility Hazard?	N/A
	Obstruction Type			Storm Grate/Utility Type	
		N/A			N/A
		Yes		Surface Condition? (G/P)	Good
		No		Curb Slope (%)	19.2

**Remove & Replace Curb Ramp With Two New Directional Ramps or Equivalent.**

**Not Found, R304.5.3**
