Access Compliance Report

Public Rights-of-Way

(Curb Ramps)

Intersection ID: 11911	Main Street: W_7TH_ST	Cross Street: N_CHURCH_ST	Location: W
ADA ID: 488EF4AE92AE	Ramp Type: PerpDiag	Initial Pass/Fail: Fail	Overall Compliance: No
Severity Score: 8.75			
Codes/Mitigation Info/Possible Solution		Field Measurements/Component Compliance

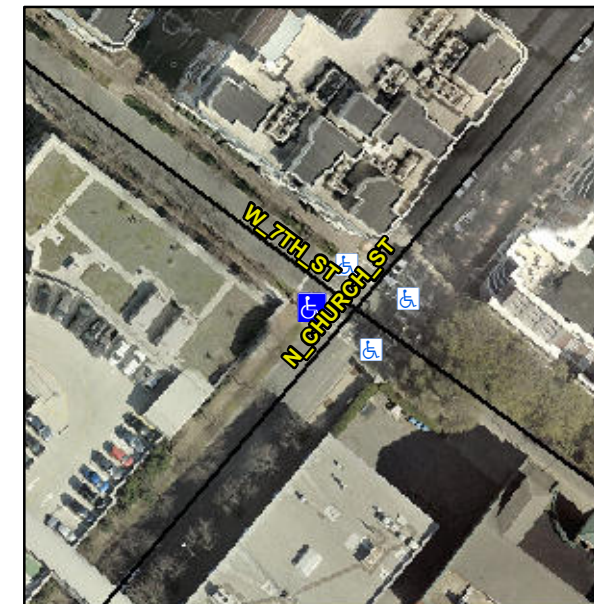
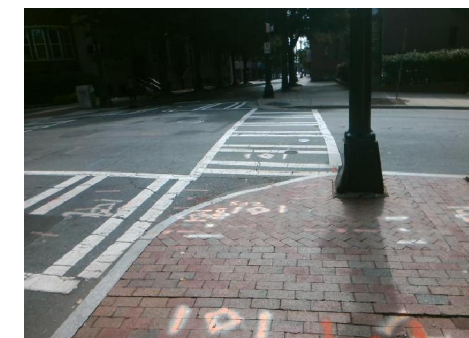
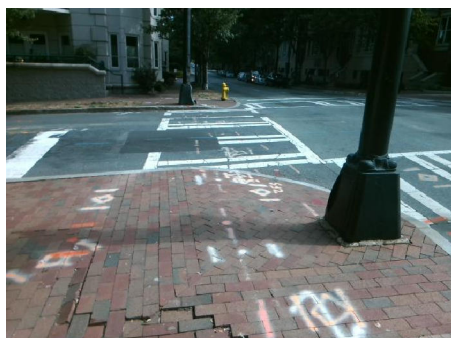
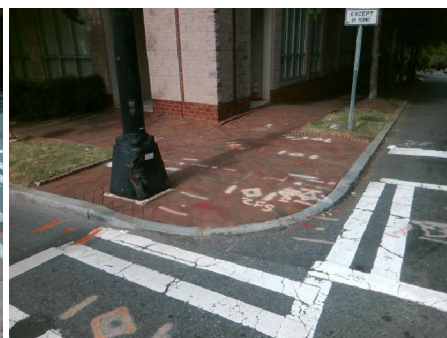
Compliance	Description	Data	Compliance	Description	Data
N/A	Ramp Length (in)	66.0	Yes	Ramp Slope (%)	5.8
No	Ramp Width (in)	41.0	Yes	Ramp XSlope (%)	1.9
N/A	Flare Type LT	N/A	N/A	Flare Type RT	N/A
N/A	Flare Slope LT (%)	N/A	N/A	Flare Slope RT (%)	N/A
N/A	Flare Traversable LT?	N/A	N/A	Flare Traversable RT?	N/A
N/A	Landing Length (in)	N/A	N/A	DWS Provided?	N/A
N/A	Landing Width (in)	N/A	N/A	DWS Contrast?	N/A
N/A	Landing Slope (%)	N/A	N/A	DWS Length (in)	N/A
N/A	Landing X Slope (%)	N/A	N/A	DWS Full Width?	N/A
N/A	Landing Curb? (Y/N)	N/A	N/A	DWS Offset (in)	N/A
N/A	Shared Landing?	N/A			
N/A	Gutter Ponding?	N/A	N/A	Gutter Slope (%)	N/A
N/A	Gutter Lip Ht (in)	N/A	N/A	Gutter X Slope (%)	N/A
N/A	Painted X Walk1?	Yes	N/A	Painted X Walk2?	Yes
	X Walk 1 Direction	To SE		X Walk 2 Direction	To NE
N/A	X Walk 1 Width (in)	83.0	N/A	X Walk 2 Width (in)	99.0
	X Walk 1 Slope (%)	6.1		X Walk 2 Slope (%)	4.7
	X Walk 1 X Slope (%)	5.0		X Walk 2 X Slope (%)	4.5

N/A	Ramp inside XWalk1?	Yes	N/A	Ramp inside XWalk2?	Yes
	Road Slope (%)	0.8	N/A	Clear Space?	N/A
	Road X Slope (%)	9.4	N/A	Clear Space to XWalk (in)	N/A
N/A	Any Obstructions?	N/A	N/A	Storm Grate/Utility Hazard?	N/A
	Obstruction Type			Storm Grate/Utility Type	
		N/A			N/A
		Yes		Surface Condition? (G/P)	Good

Possible Solutions:

Remove & Replace Curb Ramp With Two New Directional Ramps or Equivalent.

R304.5.1
