Access Compliance Report

Public Rights-of-Way (Curb Ramps)

Intersection ID: 10051	Main Street: LAKEDELL_DR	Cross Street: RUTH_DR	Location: NW
ADA ID: 48A2544E8B7B	Ramp Type: Perp	Initial Pass/Fail: Fail	Overall Compliance: No
Severity Score: 12.5			
Codes/Mitigation Info/Possible Solution		Field Measurements/Component Compliance

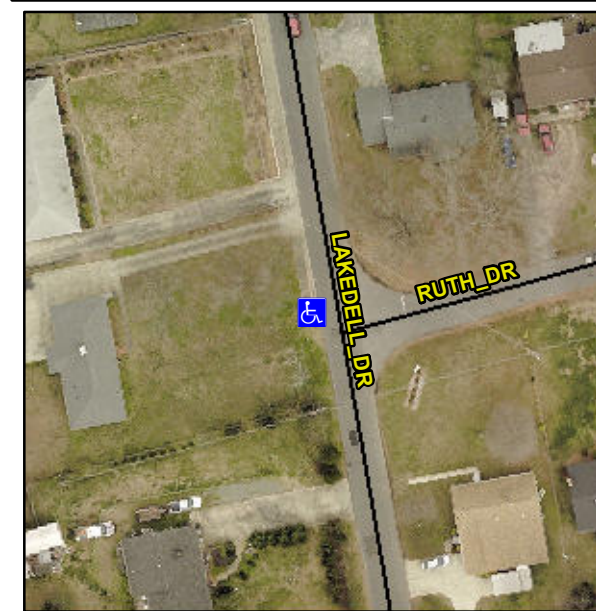
Compliance	Description	Data	Compliance	Description	Data
N/A	Ramp Length (in)	60.0	No	Ramp Slope (%)	9.6
Yes	Ramp Width (in)	88.0	Yes	Ramp XSlope (%)	1.6
N/A	Flare Type LT	N/A	N/A	Flare Type RT	N/A
N/A	Flare Slope LT (%)	N/A	N/A	Flare Slope RT (%)	N/A
N/A	Flare Traversable LT?	N/A	N/A	Flare Traversable RT?	N/A
N/A	Landing Length (in)	N/A	N/A	DWS Provided?	N/A
N/A	Landing Width (in)	N/A	N/A	DWS Contrast?	N/A
N/A	Landing Slope (%)	N/A	N/A	DWS Length (in)	N/A
N/A	Landing X Slope (%)	N/A	N/A	DWS Full Width?	N/A
N/A	Landing Curb? (Y/N)	N/A	N/A	DWS Offset (in)	N/A
N/A	Shared Landing?	N/A			
N/A	Gutter Ponding?	N/A	N/A	Gutter Slope (%)	N/A
N/A	Gutter Lip Ht (in)	1.0	N/A	Gutter X Slope (%)	N/A
N/A	Painted X Walk1?	No	N/A	Painted X Walk2?	N/A
	X Walk 1 Direction	To E		X Walk 2 Direction	N/A
N/A	X Walk 1 Width (in)	N/A	N/A	X Walk 2 Width (in)	N/A
	X Walk 1 Slope (%)	5.7		X Walk 2 Slope (%)	N/A
	X Walk 1 X Slope (%)	1.0		X Walk 2 X Slope (%)	N/A

N/A	Ramp inside XWalk1?	N/A	N/A	Ramp inside XWalk2?	N/A
	Road Slope (%)	1.0	N/A	Clear Space?	N/A
	Road X Slope (%)	5.7	N/A	Clear Space to XWalk (in)	N/A
N/A	Any Obstructions?	N/A	N/A	Storm Grate/Utility Hazard?	N/A
	Obstruction Type			Storm Grate/Utility Type	
		N/A			N/A
		Yes		Surface Condition? (G/P)	Good

Remove & Replace Entire Ramp.
