# Access Compliance Report

## Public Rights-of-Way

### (Curb Ramps)

| Intersection ID: 28076 | Main Street: ALEXANDER MARTIN AV | Cross Street: REA RD | Location: SW |

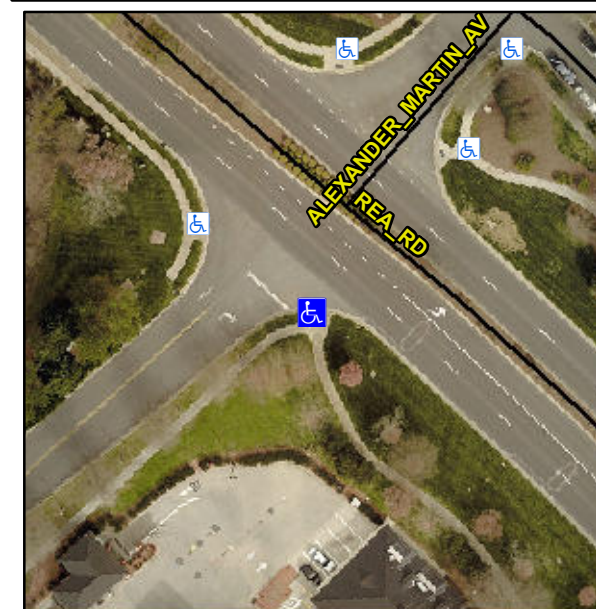
| ADA ID: 48AF8811A539 | Ramp Type: Perp | Initial Pass/Fail: Fail | Overall Compliance: No |
| Severity Score: 1.25 | | | |

**Not Found, R304.5.3**

| Compliance | Description | Data | Compliance | Description | Data |
|---|---|---|---|---|---|
| Yes | Ramp Width (in) | 52.0 | No | Ramp XSlope (%) | 2.3 |

**Remove & Replace Entire Ramp.**

Total Cost: \$ 1850.00
