# Access Compliance Report

## Public Rights-of-Way

### (Curb Ramps)

Intersection ID: 47019	Main Street: TRIBUNE_DR	Cross Street: MARKHAM_WOODS_CT	Location: N
ADA ID: 48B318D82A61	Ramp Type: Perp	Initial Pass/Fail: Fail	Overall Compliance: No
			Severity Score: 21.25

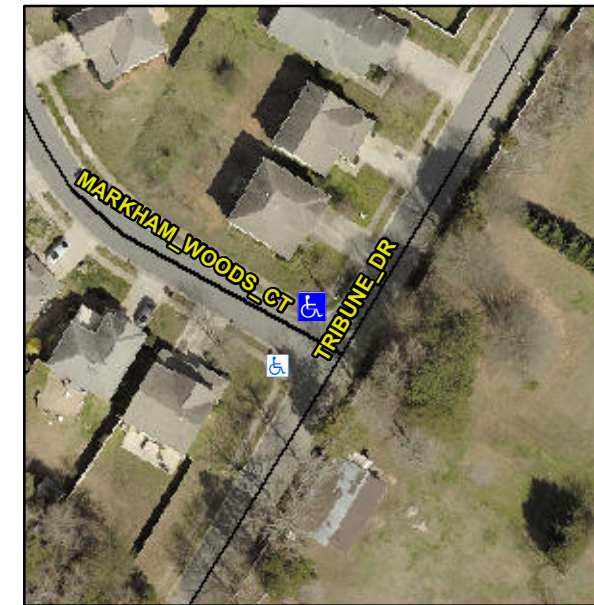
**Not Found, R304.5.1, R304.5.3**

Compliance	Description	Data	Compliance	Description	Data
N/A	Ramp Length (in)	46.5	Yes	Ramp Slope (%)	8.1
No	Ramp Width (in)	46.5	No	Ramp XSlope (%)	5.5
N/A	Flare Type LT	N/A	N/A	Flare Type RT	N/A
N/A	Flare Slope LT (%)	N/A	N/A	Flare Slope RT (%)	N/A
N/A	Flare Traversable LT?	N/A	N/A	Flare Traversable RT?	N/A
N/A	Landing Length (in)	N/A	N/A	DWS Provided?	N/A
N/A	Landing Width (in)	N/A	N/A	DWS Contrast?	N/A
N/A	Landing Slope (%)	N/A	N/A	DWS Length (in)	N/A
N/A	Landing X Slope (%)	N/A	N/A	DWS Full Width?	N/A
N/A	Landing Curb? (Y/N)	N/A	N/A	DWS Offset (in)	N/A
N/A	Shared Landing?	N/A			
N/A	Gutter Ponding?	N/A	N/A	Gutter Slope (%)	N/A
N/A	Gutter Lip Ht (in)	N/A	N/A	Gutter X Slope (%)	N/A
N/A	Painted X Walk1?	No	N/A	Painted X Walk2?	N/A
	X Walk 1 Direction	To SW		X Walk 2 Direction	N/A
N/A	X Walk 1 Width (in)	N/A	N/A	X Walk 2 Width (in)	N/A
	X Walk 1 Slope (%)	0.9		X Walk 2 Slope (%)	N/A
	X Walk 1 X Slope (%)	4.5		X Walk 2 X Slope (%)	N/A

N/A	Ramp inside XWalk1?	N/A	N/A	Ramp inside XWalk2?	N/A
	Road Slope (%)	N/A	N/A	Clear Space?	N/A
	Road X Slope (%)	N/A	N/A	Clear Space to XWalk (in)	N/A
N/A	Any Obstructions?	N/A	N/A	Storm Grate/Utility Hazard?	N/A
	Obstruction Type			Storm Grate/Utility Type	
		N/A			N/A
			Yes	Surface Condition? (G/P)	Good

**Remove & Replace Entire Ramp.**
