# Access Compliance Report

## Public Rights-of-Way

### (Curb Ramps)

Intersection ID: 10023454	Main Street: CIERA_NICHOLE_CT	Cross Street: N/A	Location:	N
ADA ID: 48B9A7A9686B	Ramp Type: Perp	Initial Pass/Fail: Fail	Overall Compliance: No	Severity Score: 35
Codes/Mitigation Info/Possible Solution		Field Measurements/Component Compliance

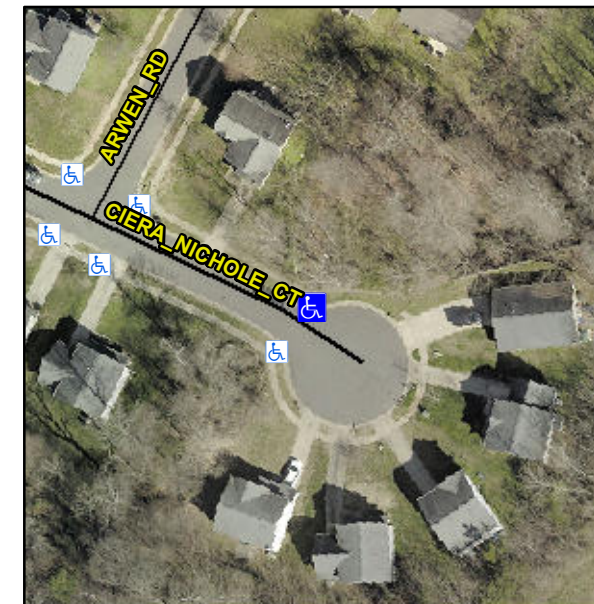
**Not Found, R304.5.1, R304.2.2, R304.5.3**

Compliance	Description	Data	Compliance	Description	Data
N/A	Ramp Length (in)	47.0	No	Ramp Slope (%)	14.0
No	Ramp Width (in)	41.0	No	Ramp XSlope (%)	3.0
N/A	Flare Type LT	N/A	N/A	Flare Type RT	N/A
N/A	Flare Slope LT (%)	N/A	N/A	Flare Slope RT (%)	N/A
N/A	Flare Traversable LT?	N/A	N/A	Flare Traversable RT?	N/A
N/A	Landing Length (in)	N/A	N/A	DWS Provided?	N/A
N/A	Landing Width (in)	N/A	N/A	DWS Contrast?	N/A
N/A	Landing Slope (%)	N/A	N/A	DWS Length (in)	N/A
N/A	Landing X Slope (%)	N/A	N/A	DWS Full Width?	N/A
N/A	Landing Curb? (Y/N)	N/A	N/A	DWS Offset (in)	N/A
N/A	Shared Landing?	N/A			
N/A	Gutter Ponding?	N/A	N/A	Gutter Slope (%)	N/A
N/A	Gutter Lip Ht (in)	N/A	N/A	Gutter X Slope (%)	N/A
N/A	Painted X Walk1?	No	N/A	Painted X Walk2?	N/A
	X Walk 1 Direction	To SW		X Walk 2 Direction	N/A
N/A	X Walk 1 Width (in)	N/A	N/A	X Walk 2 Width (in)	N/A
	X Walk 1 Slope (%)	3.4		X Walk 2 Slope (%)	N/A
	X Walk 1 X Slope (%)	2.1		X Walk 2 X Slope (%)	N/A

**Remove & Replace Entire Ramp.**

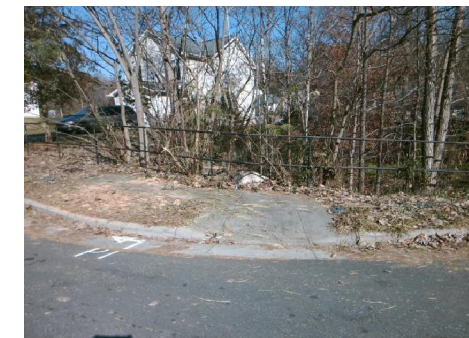
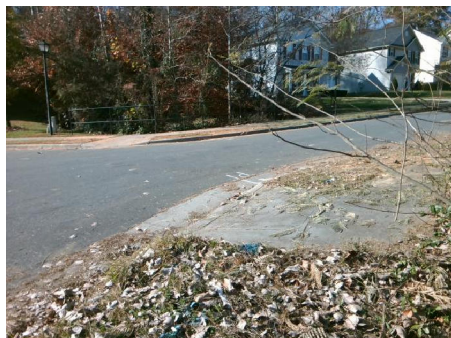
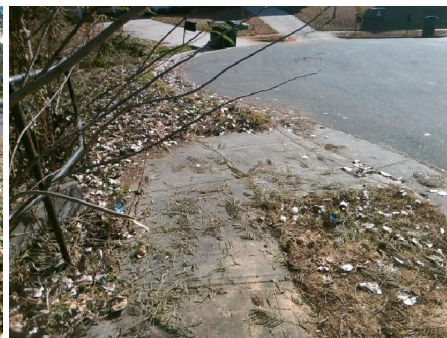
N/A	Ramp inside XWalk1?	N/A	N/A	Ramp inside XWalk2?	N/A
	Road Slope (%)	N/A	N/A	Clear Space?	N/A
	Road X Slope (%)	N/A	N/A	Clear Space to XWalk (in)	N/A
N/A	Any Obstructions?	N/A	N/A	Storm Grate/Utility Hazard?	N/A
	Obstruction Type			Storm Grate/Utility Type	
		N/A			N/A
			Yes	Surface Condition? (G/P)	Good
