Access Compliance Report Public Rights-of-Way (Curb Ramps)

Intersection ID: 10014099 Main Street: W_W_T_HARRIS_BV Cross Street: N/A Location: S

ADA ID: 48BD91261F3A Ramp Type: ParaDiag Initial Pass/Fail: Fail Overall Compliance: No Severity Score: 37.5

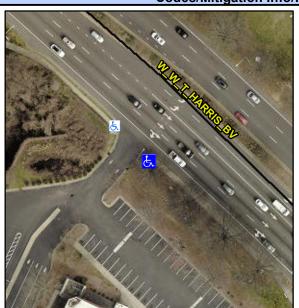
MEDIAN ACROSS W W T HARRIS
BV

Compliance Description Data Compliance Description Data N/A N/A Ramp Length LT (in) 38.0 Ramp Length RT (in) 45.0 Yes Ramp Width LT (in) 66.0 Yes Ramp Width RT (in) 69.0 No Ramp Slope LT (%) 14.4 Yes Ramp Slope RT (%) 3.8 Ramp XSlope LT (%) No Ramp XSlope RT (%) No 6.5 2.1 N/A Landing Length (in) N/A N/A DWS Provided? N/A N/A Landing Width (in) N/A N/A **DWS Contrast?** N/A N/A Landing Slope (%) N/A N/A DWS Length (in) N/A Landing X Slope (%) N/A N/A DWS Full Width? N/A N/A N/A Landing Curb? (Y/N) N/A N/A DWS Offset (in) N/A N/A Shared Landing? N/A N/A N/A N/A Gutter Ponding? Gutter Slope (%) N/A N/A Gutter Lip Ht (in) N/A N/A Gutter X Slope (%) N/A N/A Painted X Walk1? No N/A Painted X Walk2? No X Walk 1 Direction To NE X Walk 2 Direction To NW N/A X Walk 1 Width (in) N/A N/A X Walk 2 Width (in) N/A X Walk 1 Slope (%) 4.7 X Walk 2 Slope (%) 8.0 X Walk 1 X Slope (%) X Walk 2 X Slope (%) 6.2 1.9 N/A Ramp inside XWalk1? N/A N/A Ramp inside XWalk2? N/A 7.6 N/A N/A Road Slope (%) Clear Space? Road X Slope (%) 6.1 N/A Clear Space to XWalk (in) N/A N/A N/A Any Obstructions? N/A Storm Grate/Utility Hazard? N/A Obstruction Type Storm Grate/Utility Type N/A N/A Surface Condition? (G/P) Yes Good N/A Curb Slope (%) 5.5

Remove & Replace Curb Ramp With
Two New Directional Ramps or
Equivalent.

R304.3.2, R304.5.3
