Intersection ID: 29393	Main Street: AMBERGLADES_LN	Cross Street: GOLD_PAN_RD	Location:	SE
ADA ID: 48BF2590DEFE	Ramp Type: PerpDiag	Initial Pass/Fail: Fail	Overall Compliance: No	Severity Score: 8.75

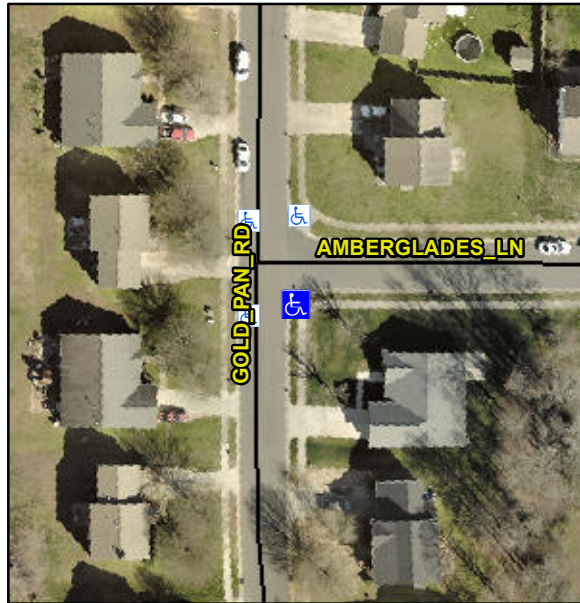
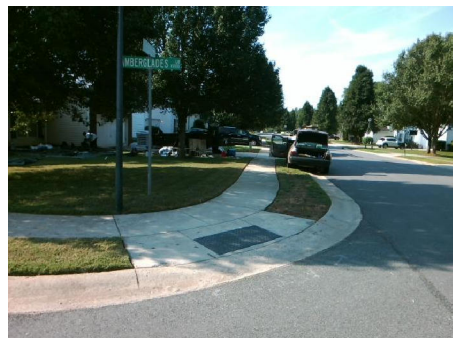
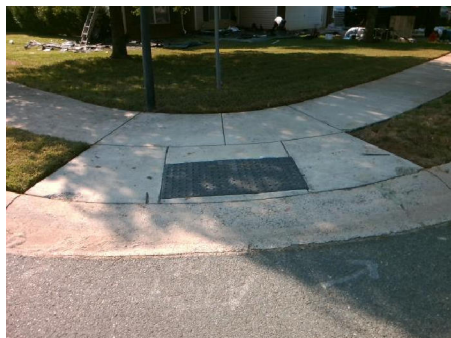
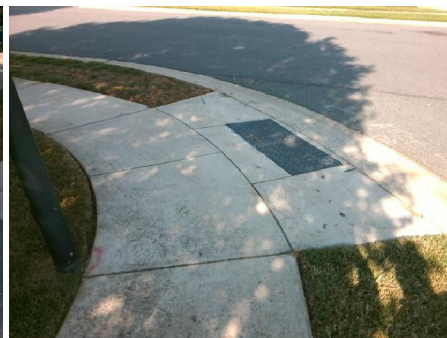
Not Found, R304.5.1

Compliance	Description	Data	Compliance	Description	Data
N/A	Ramp Length (in)	42.5	Yes	Ramp Slope (%)	6.7
No	Ramp Width (in)	47.5	Yes	Ramp XSlope (%)	0.8
N/A	Flare Type LT	N/A	N/A	Flare Type RT	N/A
N/A	Flare Slope LT (%)	N/A	N/A	Flare Slope RT (%)	N/A
N/A	Flare Traversable LT?	N/A	N/A	Flare Traversable RT?	N/A
N/A	Landing Length (in)	N/A	N/A	DWS Provided?	N/A
N/A	Landing Width (in)	N/A	N/A	DWS Contrast?	N/A
N/A	Landing Slope (%)	N/A	N/A	DWS Length (in)	N/A
N/A	Landing X Slope (%)	N/A	N/A	DWS Full Width?	N/A
N/A	Landing Curb? (Y/N)	N/A	N/A	DWS Offset (in)	N/A
N/A	Shared Landing?	N/A			
N/A	Gutter Ponding?	N/A	N/A	Gutter Slope (%)	N/A
N/A	Gutter Lip Ht (in)	N/A	N/A	Gutter X Slope (%)	N/A
N/A	Painted X Walk1?	No	N/A	Painted X Walk2?	No
	X Walk 1 Direction	To N		X Walk 2 Direction	To W
N/A	X Walk 1 Width (in)	N/A	N/A	X Walk 2 Width (in)	N/A
	X Walk 1 Slope (%)	3.5		X Walk 2 Slope (%)	3.9
	X Walk 1 X Slope (%)	2.2		X Walk 2 X Slope (%)	1.4

N/A	Ramp inside XWalk1?	N/A	N/A	Ramp inside XWalk2?	N/A
	Road Slope (%)	1.0	N/A	Clear Space?	N/A
	Road X Slope (%)	5.1	N/A	Clear Space to XWalk (in)	N/A
N/A	Any Obstructions?	N/A	N/A	Storm Grate/Utility Hazard?	N/A
	Obstruction Type			Storm Grate/Utility Type	
		N/A			N/A
			Yes	Surface Condition? (G/P)	Good

Remove & Replace Curb Ramp With Two New Directional Ramps or Equivalent.
