Access Compliance Report

Public Rights-of-Way

(Curb Ramps)

Intersection ID: 7918	Main Street: FRIENDLY_PL	Cross Street: SNOW_WHITE_LN	Location: NE
ADA ID: 48C08B034264	Ramp Type: Combination1	Initial Pass/Fail: Fail	Overall Compliance: No
Codes/Mitigation Info/Possible Solution			Severity Score: 35
			Field Measurements/Component Compliance

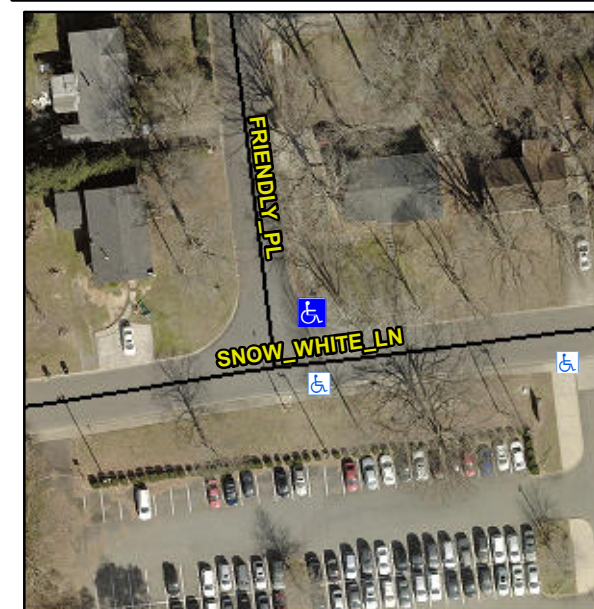
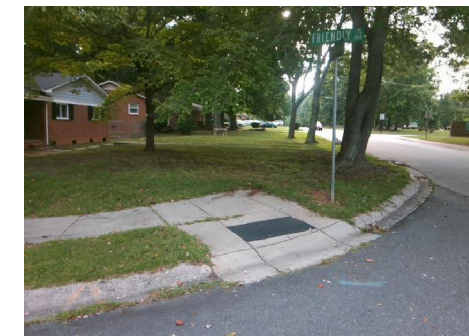
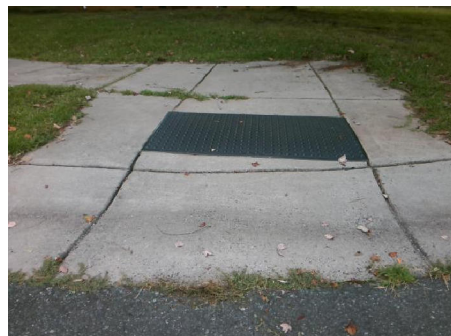
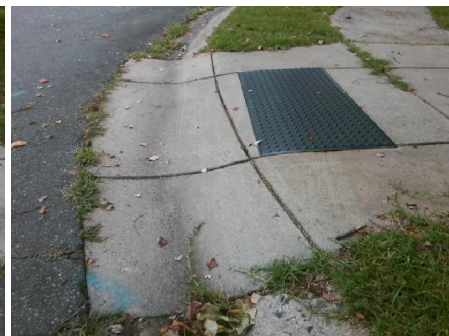
Not Found, R304.5.1, R304.2.2, R304.5.3, R304.3.2

Compliance	Description	Data	Compliance	Description	Data
N/A	Ramp Length LT (in)	29.0	N/A	Ramp Length RT (in)	N/A
Yes	Ramp Width LT (in)	60.5	N/A	Ramp Width RT (in)	N/A
No	Ramp Slope LT (%)	9.2	N/A	Ramp Slope RT (%)	N/A
Yes	Ramp XSlope LT (%)	0.7	N/A	Ramp XSlope RT (%)	N/A
N/A	Ramp Length (in)	44.0	No	Ramp Slope (%)	17.7
No	Ramp Width (in)	45.5	No	Ramp XSlope (%)	2.7
N/A	Flare Type LT	N/A	N/A	Flare Type RT	N/A
N/A	Flare Slope LT (%)	N/A	N/A	Flare Slope RT (%)	N/A
N/A	Flare Traversable LT?	N/A	N/A	Flare Traversable RT?	N/A
N/A	Landing Length (in)	N/A	N/A	DWS Provided?	N/A
N/A	Landing Width (in)	N/A	N/A	DWS Contrast?	N/A
N/A	Landing Slope (%)	N/A	N/A	DWS Length (in)	N/A
N/A	Landing X Slope (%)	N/A	N/A	DWS Full Width?	N/A
N/A	Landing Curb? (Y/N)	N/A	N/A	DWS Offset (in)	N/A
N/A	Shared Landing?	N/A			
N/A	Gutter Ponding?	N/A	N/A	Gutter Slope (%)	N/A
N/A	Gutter Lip Ht (in)	N/A	N/A	Gutter X Slope (%)	N/A
N/A	Painted X Walk1?	No	N/A	Painted X Walk2?	N/A

X Walk 1 Direction	To SW		X Walk 2 Direction	N/A
	X Walk 1 Width (in)	N/A		X Walk 2 Width (in)	N/A
	X Walk 1 Slope (%)	4.9		X Walk 2 Slope (%)	N/A
	X Walk 1 X Slope (%)	2.4		X Walk 2 X Slope (%)	N/A
N/A	Ramp inside XWalk1?	N/A	N/A	Ramp inside XWalk2?	N/A
	Road Slope (%)	N/A		Clear Space?	N/A
	Road X Slope (%)	N/A	N/A	Clear Space to XWalk (in)	N/A
			N/A	Any Obstruction?	N/A
				Obstruction Type	N/A
			N/A	Storm Grate/Utility Hazard?	N/A
				Storm Grate/Utility Type	N/A
					N/A
Yes	Surface Condition? (G/P)	Good			
	Curb Slope (%)	20.4

Possible Solutions:

Remove & Replace Entire Ramp.
