Access Compliance Report

Public Rights-of-Way

(Curb Ramps)

Intersection ID: N/A	Main Street: N COLLEGE ST	Cross Street: E 7TH ST	Location: S
ADA ID: 48C4BEA78F4D	Ramp Type: PerpDiag	Initial Pass/Fail: Fail	Overall Compliance: No
Codes/Mitigation Info/Possible Solution		Field Measurements/Component Compliance

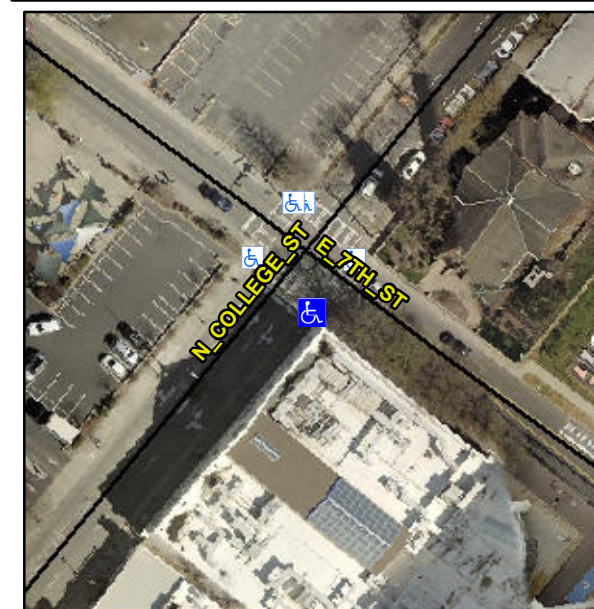
Not Found, R304.2.2

Compliance	Description	Data	Compliance	Description	Data
N/A	Ramp Length (in)	81.0	No	Ramp Slope (%)	9.1
Yes	Ramp Width (in)	60.0	Yes	Ramp XSlope (%)	3.1
N/A	Flare Type LT	N/A	N/A	Flare Type RT	N/A
N/A	Flare Slope LT (%)	N/A	N/A	Flare Slope RT (%)	N/A
N/A	Flare Traversable LT?	No	N/A	Flare Traversable RT?	No
N/A	Landing Length (in)	N/A	N/A	DWS Provided?	N/A
N/A	Landing Width (in)	N/A	N/A	DWS Contrast?	N/A
N/A	Landing Slope (%)	N/A	N/A	DWS Length (in)	N/A
N/A	Landing X Slope (%)	N/A	N/A	DWS Full Width?	N/A
N/A	Landing Curb? (Y/N)	N/A	N/A	DWS Offset (in)	N/A
N/A	Shared Landing?	N/A			
N/A	Gutter Ponding?	N/A	N/A	Gutter Slope (%)	N/A
N/A	Gutter Lip Ht (in)	N/A	N/A	Gutter X Slope (%)	N/A
N/A	Painted X Walk1?	Yes	N/A	Painted X Walk2?	Yes
	X Walk 1 Direction	To NE		X Walk 2 Direction	To NW
N/A	X Walk 1 Width (in)	116.0	N/A	X Walk 2 Width (in)	109.0
	X Walk 1 Slope (%)	1.5		X Walk 2 Slope (%)	2.7
	X Walk 1 X Slope (%)	0.7		X Walk 2 X Slope (%)	1.0

N/A	Ramp inside XWalk1?	Yes	N/A	Ramp inside XWalk2?	Yes
	Road Slope (%)	4.4	N/A	Clear Space?	N/A
	Road X Slope (%)	2.2	N/A	Clear Space to XWalk (in)	N/A
N/A	Any Obstructions?	N/A	N/A	Storm Grate/Utility Hazard?	N/A
	Obstruction Type			Storm Grate/Utility Type	
		N/A			N/A
		Yes		Surface Condition? (G/P)	Good

Remove & Replace Curb Ramp With Two New Directional Ramps or Equivalent.
