## **Access Compliance Report Public Rights-of-Way** (Curb Ramps)

Intersection ID: 10042418 Main Street: YANCEY\_RD Cross Street: N/A Location: N Overall Compliance: No Ramp Type: Perp **Severity Score:** 12.5 **ADA ID: 48CD1CEFAB7B** Initial Pass/Fail: Fail

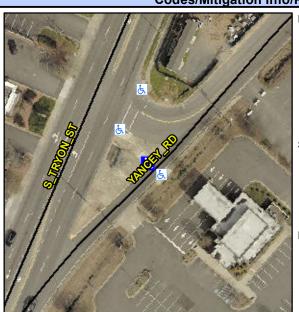
| Possible Solutions: | C |
|---|---|
| Not Found, R304.5.3 | N/ |

| Field Measurements/Component Compliance | | | | | | | |
|---|---|---|---|---|---|--|--|
| Yes | Ramp Width (in) | 60.0 | No | Ramp XSlope (%) | 6.2 | | |

| Possible Solutions: | C |
|---|---|
| Remove & Replace Entire Ramp. | N/ |
