Intersection ID: 10033945	Main Street: PARK_RD	Cross Street: N/A	Location:	NW
ADA ID: 48CE55379E43	Ramp Type: Perp	Initial Pass/Fail: Fail	Overall Compliance: No	Severity Score: 26.25

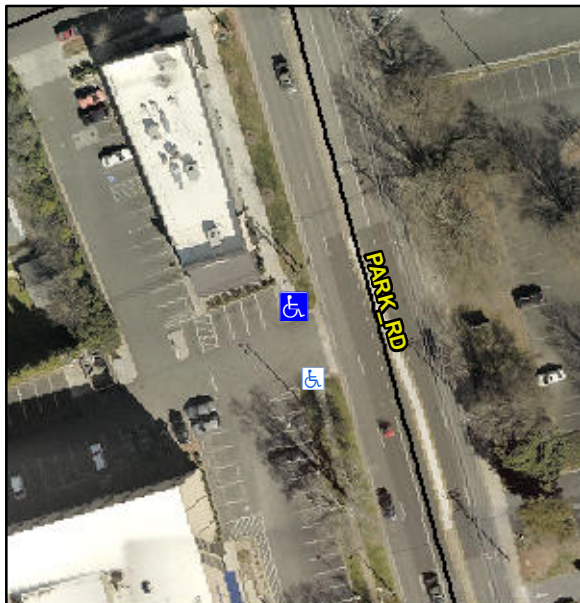
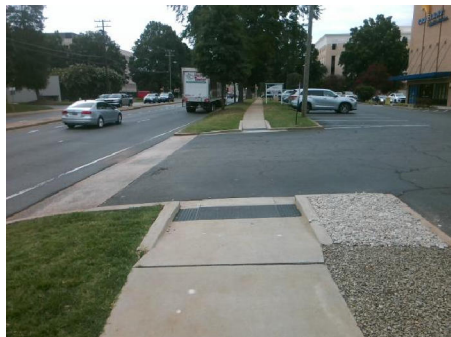
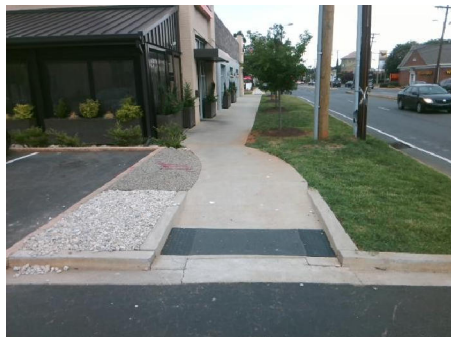
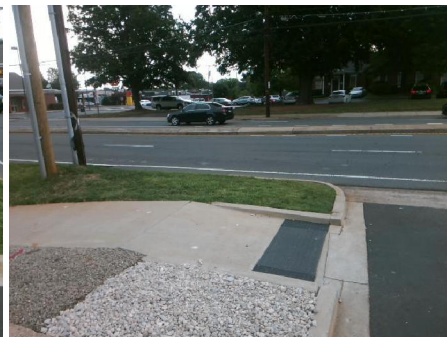
Possible Solutions:		Compliance	Description	Data	Compliance	Description	Data
	Remove & Replace Entire Ramp.		N/A	Ramp Length (in)	88.0	No	Ramp Slope (%)	12.8
			Yes	Ramp Width (in)	72.0	No	Ramp XSlope (%)	2.6
			N/A	Flare Type LT	N/A	N/A	Flare Type RT	N/A
			N/A	Flare Slope LT (%)	N/A	N/A	Flare Slope RT (%)	N/A
			N/A	Flare Traversable LT?	N/A	N/A	Flare Traversable RT?	N/A
			N/A	Landing Length (in)	N/A	N/A	DWS Provided?	N/A
			N/A	Landing Width (in)	N/A	N/A	DWS Contrast?	N/A
			N/A	Landing Slope (%)	N/A	N/A	DWS Length (in)	N/A
			N/A	Landing X Slope (%)	N/A	N/A	DWS Full Width?	N/A
Surveyor Notes:	N/A		N/A	Landing Curb? (Y/N)	N/A	N/A	DWS Offset (in)	N/A
			N/A	Shared Landing?	N/A			
			N/A	Gutter Ponding?	N/A	N/A	Gutter Slope (%)	N/A
			N/A	Gutter Lip Ht (in)	N/A	N/A	Gutter X Slope (%)	N/A
			N/A	Painted X Walk1?	No	N/A	Painted X Walk2?	N/A

X Walk 1 Direction	To S		X Walk 2 Direction	N/A
			N/A	X Walk 1 Width (in)	N/A	N/A	X Walk 2 Width (in)	N/A
				X Walk 1 Slope (%)	0.7		X Walk 2 Slope (%)	N/A
				X Walk 1 X Slope (%)	0.3		X Walk 2 X Slope (%)	N/A
			N/A	Ramp inside XWalk1?	N/A	N/A	Ramp inside XWalk2?	N/A
PROW/ADA:	Not Found, R304.2.2, R304.5.3			Road Slope (%)	N/A	N/A	Clear Space?	N/A
				Road X Slope (%)	N/A	N/A	Clear Space to XWalk (in)	N/A
			N/A	Any Obstructions?	N/A	N/A	Storm Grate/Utility Hazard?	N/A
				Obstruction Type			Storm Grate/Utility Type	
					N/A			N/A
						Yes	Surface Condition? (G/P)	Good
Street 1 Name		ENTRANCE						
Stop Condition-Street 2		None						
Street 2 Name		N/A						
Stop Condition-Street 1		N/A						
Total Cost:			\$	1850.00
