# Access Compliance Report

## Public Rights-of-Way

### (Curb Ramps)

Intersection ID: 3528	Main Street: MALLARD_CREEK_RD	Cross Street: SAWGRASS_RIDGE_PL	Location: NW
ADA ID: 48D3E849A99B	Ramp Type: Perp	Initial Pass/Fail: Fail	Overall Compliance: No
Severity Score: 25			
Codes/Mitigation Info/Possible Solution		Field Measurements/Component Compliance

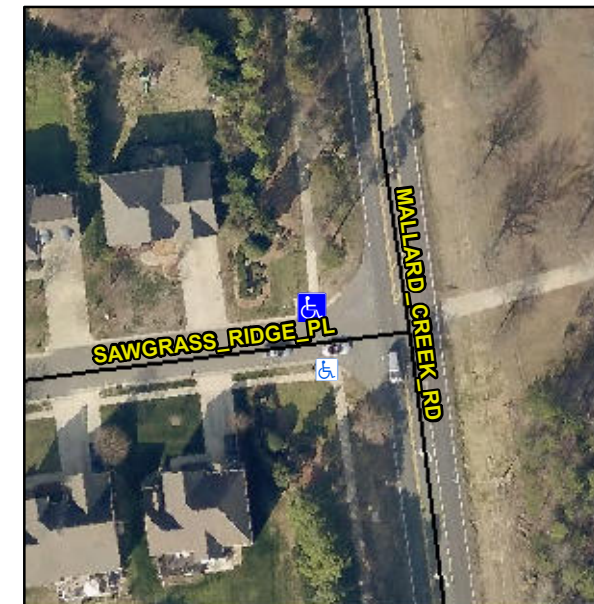
Compliance	Description	Data	Compliance	Description	Data
N/A	Ramp Length (in)	50.0	No	Ramp Slope (%)	12.5
Yes	Ramp Width (in)	48.0	Yes	Ramp XSlope (%)	0.7
N/A	Flare Type LT	N/A	N/A	Flare Type RT	N/A
N/A	Flare Slope LT (%)	N/A	N/A	Flare Slope RT (%)	N/A
N/A	Flare Traversable LT?	N/A	N/A	Flare Traversable RT?	N/A
N/A	Landing Length (in)	N/A	N/A	DWS Provided?	N/A
N/A	Landing Width (in)	N/A	N/A	DWS Contrast?	N/A
N/A	Landing Slope (%)	N/A	N/A	DWS Length (in)	N/A
N/A	Landing X Slope (%)	N/A	N/A	DWS Full Width?	N/A
N/A	Landing Curb? (Y/N)	N/A	N/A	DWS Offset (in)	N/A
N/A	Shared Landing?	N/A			
N/A	Gutter Ponding?	N/A	N/A	Gutter Slope (%)	N/A
N/A	Gutter Lip Ht (in)	N/A	N/A	Gutter X Slope (%)	N/A
N/A	Painted X Walk1?	No	N/A	Painted X Walk2?	N/A
	X Walk 1 Direction	To S		X Walk 2 Direction	N/A
N/A	X Walk 1 Width (in)	N/A	N/A	X Walk 2 Width (in)	N/A
	X Walk 1 Slope (%)	6.0		X Walk 2 Slope (%)	N/A
	X Walk 1 X Slope (%)	1.7		X Walk 2 X Slope (%)	N/A

**Remove & Replace Entire Ramp.**

**R304.2.2**

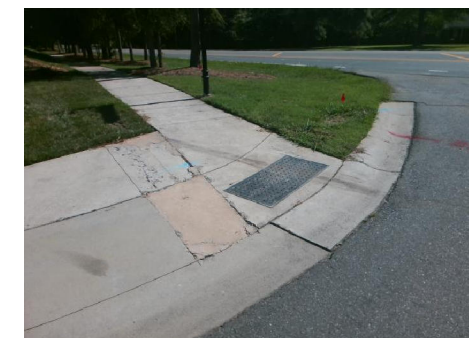
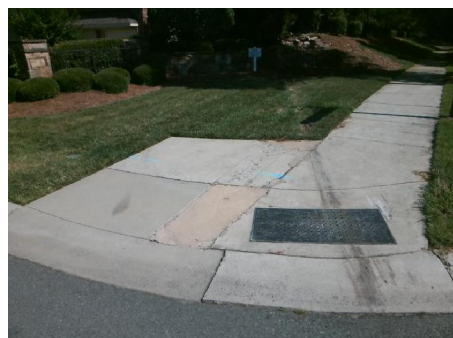
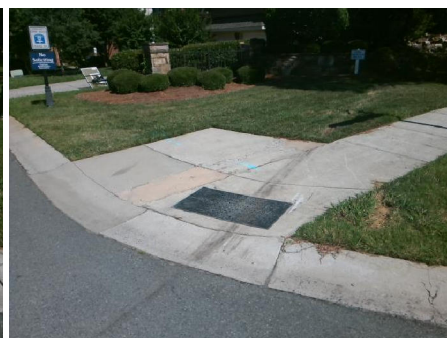
N/A	Ramp inside XWalk1?	N/A	N/A	Ramp inside XWalk2?	N/A
	Road Slope (%)	N/A	N/A	Clear Space?	N/A
	Road X Slope (%)	N/A	N/A	Clear Space to XWalk (in)	N/A
N/A	Any Obstructions?	N/A	N/A	Storm Grate/Utility Hazard?	N/A
	Obstruction Type			Storm Grate/Utility Type	
		N/A			N/A
		Yes		Surface Condition? (G/P)	Good
