Access Compliance Report

Public Rights-of-Way

Intersection ID: 50540	Main Street: DANIEL_DWAYNE_DR	Cross Street: LEMONGRASS_LN	Location: NW
ADA ID: 48D95FC8FD65	Ramp Type: PerpDiag	Initial Pass/Fail: Fail	Overall Compliance: No
Codes/Mitigation Info/Possible Solution		Field Measurements/Component Compliance	
Severity Score: 10

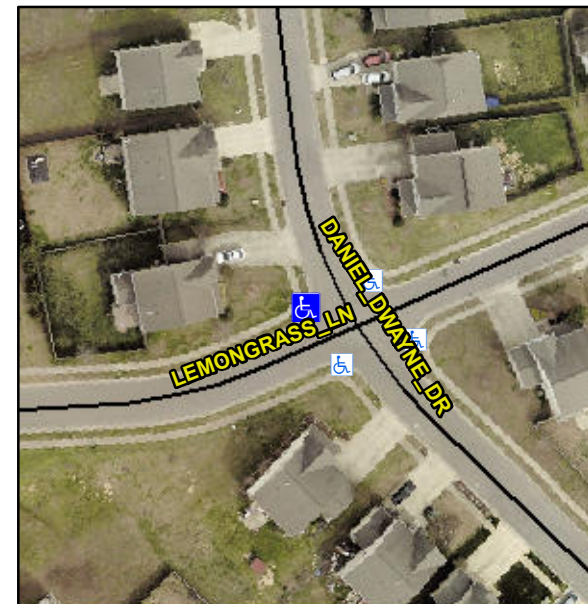
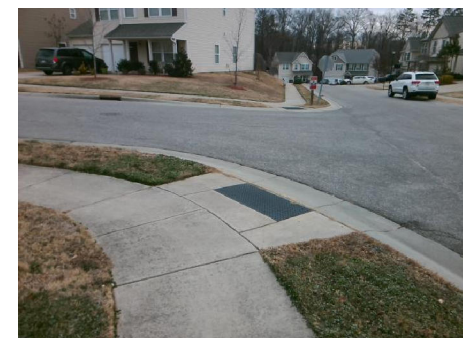
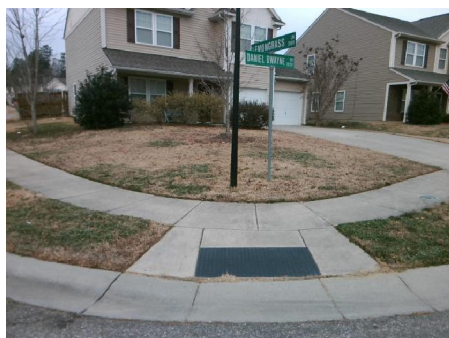
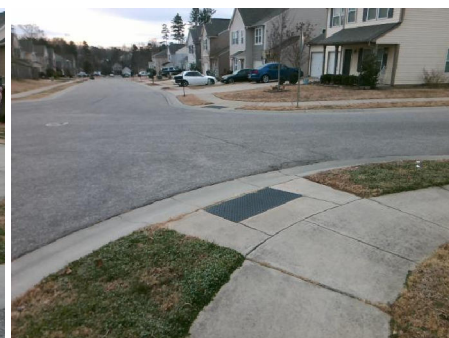
Not Found, R304.5.1, R304.5.3

Compliance	Description	Data	Compliance	Description	Data
N/A	Ramp Length (in)	48.0	Yes	Ramp Slope (%)	7.1
No	Ramp Width (in)	47.0	No	Ramp XSlope (%)	2.6
N/A	Flare Type LT	N/A	N/A	Flare Type RT	N/A
N/A	Flare Slope LT (%)	N/A	N/A	Flare Slope RT (%)	N/A
N/A	Flare Traversable LT?	N/A	N/A	Flare Traversable RT?	N/A
N/A	Landing Length (in)	N/A	N/A	DWS Provided?	N/A
N/A	Landing Width (in)	N/A	N/A	DWS Contrast?	N/A
N/A	Landing Slope (%)	N/A	N/A	DWS Length (in)	N/A
N/A	Landing X Slope (%)	N/A	N/A	DWS Full Width?	N/A
N/A	Landing Curb? (Y/N)	N/A	N/A	DWS Offset (in)	N/A
N/A	Shared Landing?	N/A			
N/A	Gutter Ponding?	N/A	N/A	Gutter Slope (%)	N/A
N/A	Gutter Lip Ht (in)	N/A	N/A	Gutter X Slope (%)	N/A
N/A	Painted X Walk1?	No	N/A	Painted X Walk2?	No
	X Walk 1 Direction	To S		X Walk 2 Direction	To E
N/A	X Walk 1 Width (in)	N/A	N/A	X Walk 2 Width (in)	N/A
	X Walk 1 Slope (%)	4.0		X Walk 2 Slope (%)	0.2
	X Walk 1 X Slope (%)	1.1		X Walk 2 X Slope (%)	3.0

N/A	Ramp inside XWalk1?	N/A	N/A	Ramp inside XWalk2?	N/A
	Road Slope (%)	2.6	N/A	Clear Space?	N/A
	Road X Slope (%)	2.5	N/A	Clear Space to XWalk (in)	N/A
N/A	Any Obstructions?	N/A	N/A	Storm Grate/Utility Hazard?	N/A
	Obstruction Type			Storm Grate/Utility Type	
		N/A			N/A
			Yes	Surface Condition? (G/P)	Good

Remove & Replace Curb Ramp With Two New Directional Ramps or Equivalent.
