Access Compliance Report

Public Rights-of-Way

(Curb Ramps)

Intersection ID: 24868	Main Street: PARK_RD	Cross Street: PARK_CROSSING_DR	Location: NW
ADA ID: 48E710F8EABB	Ramp Type: PerpDiag	Initial Pass/Fail: Fail	Overall Compliance: No
			Severity Score: 13.75

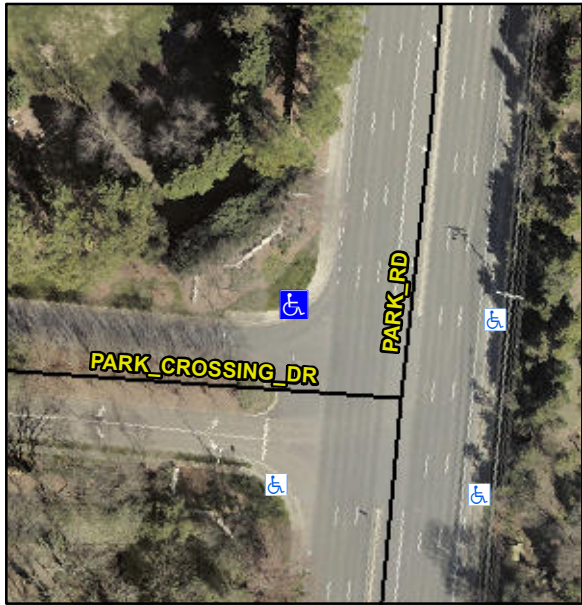
Possible Solutions:		Compliance	Description	Data	Compliance	Description	Data
	Remove & Replace Curb Ramp With Two New Directional Ramps or Equivalent.		N/A	Ramp Length (in)	60.0	No	Ramp Slope (%)	8.7
			Yes	Ramp Width (in)	48.0	No	Ramp XSlope (%)	2.4
			N/A	Flare Type LT	N/A	N/A	Flare Type RT	N/A
			N/A	Flare Slope LT (%)	N/A	N/A	Flare Slope RT (%)	N/A
			N/A	Flare Traversable LT?	N/A	N/A	Flare Traversable RT?	N/A
			N/A	Landing Length (in)	N/A	N/A	DWS Provided?	N/A
			N/A	Landing Width (in)	N/A	N/A	DWS Contrast?	N/A
			N/A	Landing Slope (%)	N/A	N/A	DWS Length (in)	N/A
			N/A	Landing X Slope (%)	N/A	N/A	DWS Full Width?	N/A
Surveyor Notes:	N/A		N/A	Landing Curb? (Y/N)	N/A	N/A	DWS Offset (in)	N/A
			N/A	Shared Landing?	N/A			
			N/A	Gutter Ponding?	N/A	N/A	Gutter Slope (%)	N/A
			N/A	Gutter Lip Ht (in)	N/A	N/A	Gutter X Slope (%)	N/A

N/A	Painted X Walk1?	No	N/A	Painted X Walk2?	No
				X Walk 1 Direction	To SW		X Walk 2 Direction	To SE
			N/A	X Walk 1 Width (in)	N/A	N/A	X Walk 2 Width (in)	N/A
				X Walk 1 Slope (%)	2.2		X Walk 2 Slope (%)	2.1
				X Walk 1 X Slope (%)	1.9		X Walk 2 X Slope (%)	0.2
			N/A	Ramp inside XWalk1?	N/A	N/A	Ramp inside XWalk2?	N/A
PROW/ADA:	Not Found, R304.2.2, R304.5.3			Road Slope (%)	0.8	N/A	Clear Space?	N/A
				Road X Slope (%)	3.8	N/A	Clear Space to XWalk (in)	N/A
			N/A	Any Obstructions?	N/A	N/A	Storm Grate/Utility Hazard?	N/A
				Obstruction Type			Storm Grate/Utility Type	
					N/A			N/A
						Yes	Surface Condition? (G/P)	Good
Total Cost:		\$ 3200.00
