Access Compliance Report

Public Rights-of-Way

(Curb Ramps)

Intersection ID: N/A	Main Street: MONROE_RD	Cross Street: N/A	Location: SE
ADA ID: 48F1C2D46178	Ramp Type: Perp	Initial Pass/Fail: Fail	Overall Compliance: No
Codes/Mitigation Info/Possible Solution		Field Measurements/Component Compliance	
Severity Score: 26.25

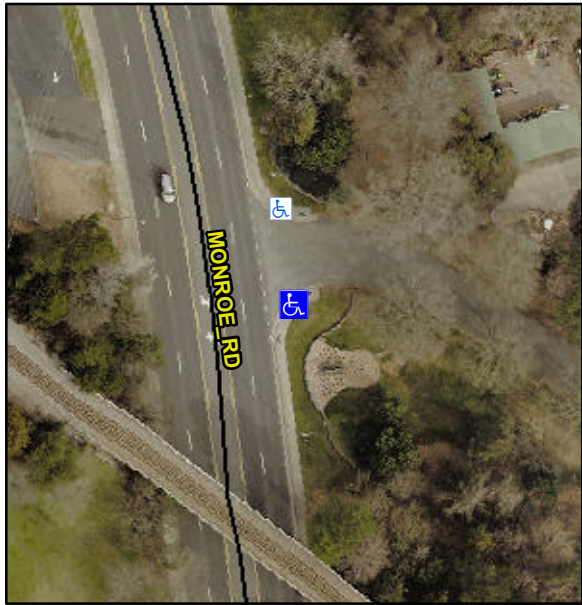
Possible Solutions:		Compliance		Description	Data	Compliance		Description	Data
	Remove & Replace Entire Ramp.		N/A	Ramp Length (in)	63.0	No	Ramp Slope (%)	12.0		
			Yes	Ramp Width (in)	48.0	No	Ramp XSlope (%)	4.5		
			N/A	Flare Type LT	N/A	N/A	Flare Type RT	N/A		
			N/A	Flare Slope LT (%)	N/A	N/A	Flare Slope RT (%)	N/A		
			N/A	Flare Traversable LT?	N/A	N/A	Flare Traversable RT?	N/A		
			N/A	Landing Length (in)	N/A	N/A	DWS Provided?	N/A		
			N/A	Landing Width (in)	N/A	N/A	DWS Contrast?	N/A		
			N/A	Landing Slope (%)	N/A	N/A	DWS Length (in)	N/A		
			N/A	Landing X Slope (%)	N/A	N/A	DWS Full Width?	N/A		
<p>Surveyor Notes:</p> <p>N/A</p> <p>PROW/ADA:</p> <p>Not Found, R304.2.2, R304.5.3</p>			N/A	Landing Curb? (Y/N)	N/A	N/A	DWS Offset (in)	N/A		
			N/A	Shared Landing?	N/A					
			N/A	Gutter Ponding?	N/A	N/A	Gutter Slope (%)	N/A		
			N/A	Gutter Lip Ht (in)	N/A	N/A	Gutter X Slope (%)	N/A		
			N/A	Painted X Walk1?	No	N/A	Painted X Walk2?	N/A

X Walk 1 Direction	To N		X Walk 2 Direction	N/A		
			N/A	X Walk 1 Width (in)	N/A	N/A	X Walk 2 Width (in)	N/A		
				X Walk 1 Slope (%)	8.4		X Walk 2 Slope (%)	N/A		
				X Walk 1 X Slope (%)	4.9		X Walk 2 X Slope (%)	N/A		
			N/A	Ramp inside XWalk1?	N/A	N/A	Ramp inside XWalk2?	N/A		
<p>Street 1 Name</p> <p>Stop Condition-Street 2</p> <p>Street 2 Name</p> <p>Stop Condition-Street 1</p>				Road Slope (%)	N/A	N/A	Clear Space?	N/A		
				Road X Slope (%)	N/A	N/A	Clear Space to XWalk (in)	N/A		
			N/A	Any Obstructions?	N/A	N/A	Storm Grate/Utility Hazard?	N/A		
				Obstruction Type			Storm Grate/Utility Type			
						N/A		N/A		
						Yes	Surface Condition? (G/P)	Good
