Access Compliance Report

Public Rights-of-Way

(Curb Ramps)

Intersection ID: 5680	Main Street: OAKDALE_RD	Cross Street: CRAPE_MYRTLE_LN	Location: NW
ADA ID: 48FB9F625ED2	Ramp Type: Perp	Initial Pass/Fail: Fail	Overall Compliance: No
Severity Score: 25			
Codes/Mitigation Info/Possible Solution		Field Measurements/Component Compliance

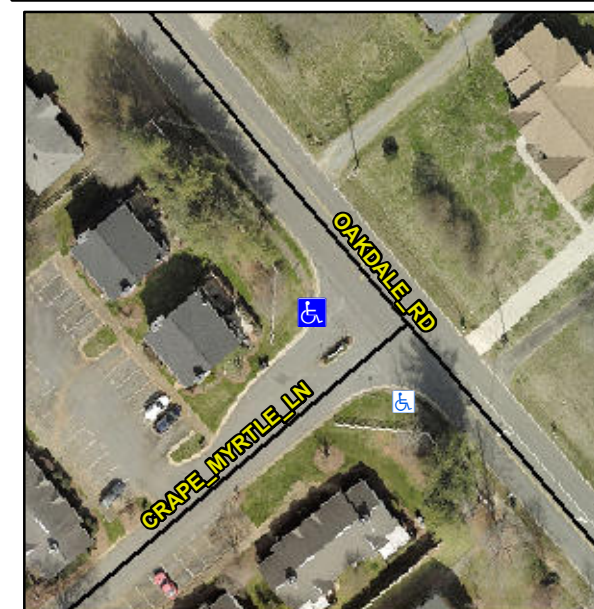
Not Found, R304.2.2

Compliance	Description	Data	Compliance	Description	Data
N/A	Ramp Length (in)	32.0	No	Ramp Slope (%)	13.1
Yes	Ramp Width (in)	48.0	Yes	Ramp XSlope (%)	1.3
N/A	Flare Type LT	N/A	N/A	Flare Type RT	N/A
N/A	Flare Slope LT (%)	N/A	N/A	Flare Slope RT (%)	N/A
N/A	Flare Traversable LT?	N/A	N/A	Flare Traversable RT?	N/A
N/A	Landing Length (in)	N/A	N/A	DWS Provided?	N/A
N/A	Landing Width (in)	N/A	N/A	DWS Contrast?	N/A
N/A	Landing Slope (%)	N/A	N/A	DWS Length (in)	N/A
N/A	Landing X Slope (%)	N/A	N/A	DWS Full Width?	N/A
N/A	Landing Curb? (Y/N)	N/A	N/A	DWS Offset (in)	N/A
N/A	Shared Landing?	N/A			
N/A	Gutter Ponding?	N/A	N/A	Gutter Slope (%)	N/A
N/A	Gutter Lip Ht (in)	N/A	N/A	Gutter X Slope (%)	N/A
N/A	Painted X Walk1?	No	N/A	Painted X Walk2?	N/A
	X Walk 1 Direction	To SE		X Walk 2 Direction	N/A
N/A	X Walk 1 Width (in)	N/A	N/A	X Walk 2 Width (in)	N/A
	X Walk 1 Slope (%)	5.7		X Walk 2 Slope (%)	N/A
	X Walk 1 X Slope (%)	4.2		X Walk 2 X Slope (%)	N/A

Possible Solutions:

Remove & Replace Entire Ramp.
