# Access Compliance Report

## Public Rights-of-Way

### (Curb Ramps)

| Intersection ID: 26627 | Main Street: SAVANNAH_HILLS_DR | Cross Street: MCKEE_RD | Location: SE |

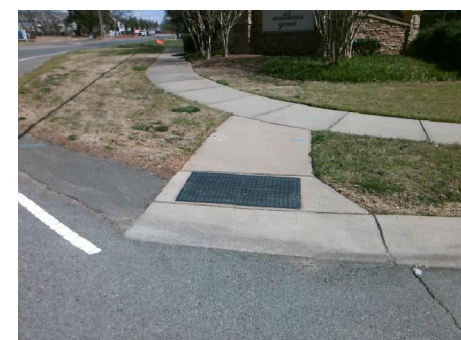
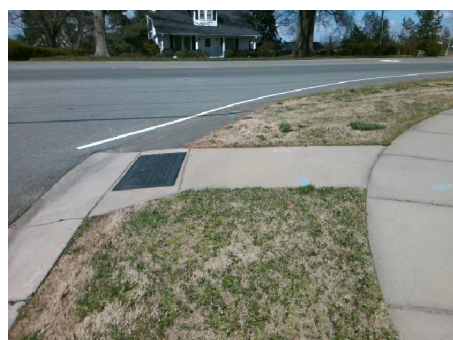
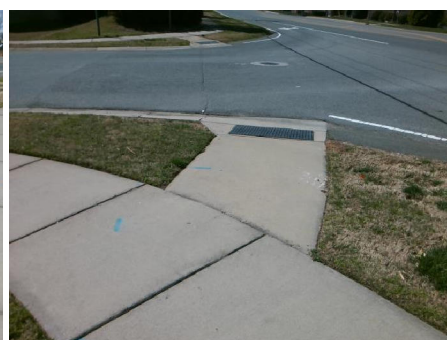
| ADA ID: 48FD051DD3CB | Ramp Type: Perp | Initial Pass/Fail: Fail | Overall Compliance: No |

**Not Found, R304.2.2, R304.5.3**

| Compliance | Description | Data | Compliance | Description | Data |
|---|---|---|---|---|---|
| N/A | Ramp Length (in) | 28.0 | No | Ramp Slope (%) | 8.9 |
| Yes | Ramp Width (in) | 60.0 | No | Ramp XSlope (%) | 3.8 |

**Remove & Replace Entire Ramp.**
