# Access Compliance Report Public Rights-of-Way (Curb Ramps)

Intersection ID: 5672	Main Street: SUNSET_RD	Cross Street: BEATTIES_FORD_RD	Location: SW
ADA ID: 48FE587EE929	Ramp Type: Perp	Initial Pass/Fail: Fail	Overall Compliance: No Severity Score: 8.75

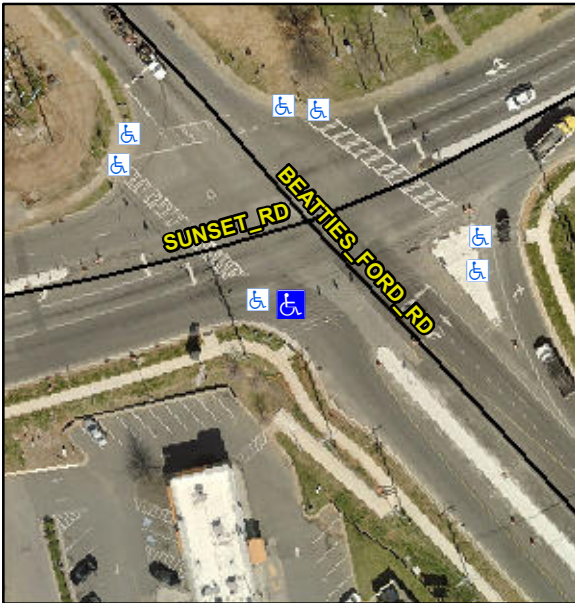
**Not Found, R304.5.1**

Compliance	Description	Data	Compliance	Description	Data
N/A	Ramp Length (in)	50.0	Yes	Ramp Slope (%)	5.3
No	Ramp Width (in)	44.0	Yes	Ramp XSlope (%)	0.1
N/A	Flare Type LT	N/A	N/A	Flare Type RT	N/A
N/A	Flare Slope LT (%)	N/A	N/A	Flare Slope RT (%)	N/A
N/A	Flare Traversable LT?	N/A	N/A	Flare Traversable RT?	N/A
N/A	Landing Length (in)	N/A	N/A	DWS Provided?	N/A
N/A	Landing Width (in)	N/A	N/A	DWS Contrast?	N/A
N/A	Landing Slope (%)	N/A	N/A	DWS Length (in)	N/A
N/A	Landing X Slope (%)	N/A	N/A	DWS Full Width?	N/A
N/A	Landing Curb? (Y/N)	N/A	N/A	DWS Offset (in)	N/A
N/A	Shared Landing?	N/A			
N/A	Gutter Ponding?	N/A	N/A	Gutter Slope (%)	N/A
N/A	Gutter Lip Ht (in)	N/A	N/A	Gutter X Slope (%)	N/A
N/A	Painted X Walk1?	Yes	N/A	Painted X Walk2?	N/A
	X Walk 1 Direction	To E		X Walk 2 Direction	N/A
N/A	X Walk 1 Width (in)	92.0	N/A	X Walk 2 Width (in)	N/A
	X Walk 1 Slope (%)	1.8		X Walk 2 Slope (%)	N/A
	X Walk 1 X Slope (%)	2.7		X Walk 2 X Slope (%)	N/A

N/A	Ramp inside XWalk1?	Yes	N/A	Ramp inside XWalk2?	N/A
	Road Slope (%)	N/A	N/A	Clear Space?	N/A
	Road X Slope (%)	N/A	N/A	Clear Space to XWalk (in)	N/A
N/A	Any Obstructions?	N/A	N/A	Storm Grate/Utility Hazard?	N/A
	Obstruction Type			Storm Grate/Utility Type	
			N/A		N/A
			Yes	Surface Condition? (G/P)	Good

**Remove & Replace Entire Ramp.**
