Access Compliance Report

Public Rights-of-Way

(Curb Ramps)

Intersection ID: N/A	Main Street: E_STONEWALL_ST	Cross Street: S_MCDOWELL_ST	Location: W
ADA ID: 490C33956B30	Ramp Type: PerpDiag	Initial Pass/Fail: Fail	Overall Compliance: No
		Severity Score: 37.5	
Codes/Mitigation Info/Possible Solution		Field Measurements/Component Compliance

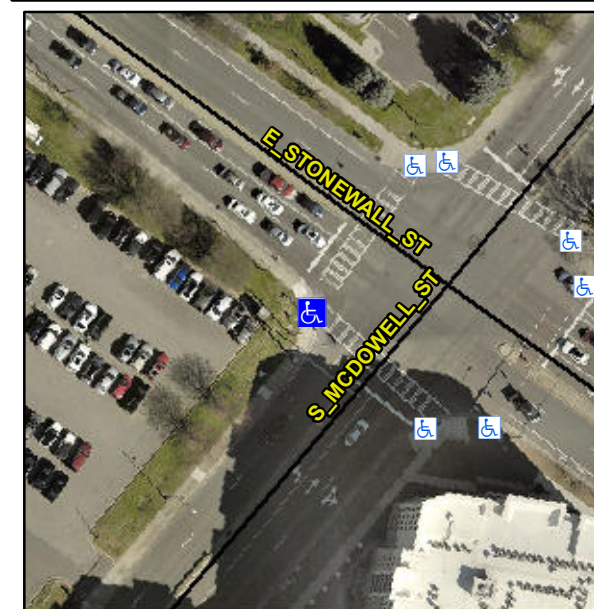
Not Found, R304.2.2, R304.5.3

Compliance	Description	Data	Compliance	Description	Data
N/A	Ramp Length (in)	72.0	No	Ramp Slope (%)	9.0
Yes	Ramp Width (in)	48.0	No	Ramp XSlope (%)	7.5
N/A	Flare Type LT	N/A	N/A	Flare Type RT	N/A
N/A	Flare Slope LT (%)	N/A	N/A	Flare Slope RT (%)	N/A
N/A	Flare Traversable LT?	No	N/A	Flare Traversable RT?	No
N/A	Landing Length (in)	N/A	N/A	DWS Provided?	N/A
N/A	Landing Width (in)	N/A	N/A	DWS Contrast?	N/A
N/A	Landing Slope (%)	N/A	N/A	DWS Length (in)	N/A
N/A	Landing X Slope (%)	N/A	N/A	DWS Full Width?	N/A
N/A	Landing Curb? (Y/N)	N/A	N/A	DWS Offset (in)	N/A
N/A	Shared Landing?	N/A			
N/A	Gutter Ponding?	N/A	N/A	Gutter Slope (%)	N/A
N/A	Gutter Lip Ht (in)	N/A	N/A	Gutter X Slope (%)	N/A
N/A	Painted X Walk1?	Yes	N/A	Painted X Walk2?	Yes
	X Walk 1 Direction	To SE		X Walk 2 Direction	To NE
N/A	X Walk 1 Width (in)	103.0	N/A	X Walk 2 Width (in)	119.0
	X Walk 1 Slope (%)	7.3		X Walk 2 Slope (%)	4.2
	X Walk 1 X Slope (%)	5.5		X Walk 2 X Slope (%)	1.1

N/A	Ramp inside XWalk1?	Yes	N/A	Ramp inside XWalk2?	Yes
	Road Slope (%)	7.0	N/A	Clear Space?	N/A
	Road X Slope (%)	1.9	N/A	Clear Space to XWalk (in)	N/A
N/A	Any Obstructions?	N/A	N/A	Storm Grate/Utility Hazard?	N/A
	Obstruction Type			Storm Grate/Utility Type	
		N/A			N/A
		Yes		Surface Condition? (G/P)	Good

Possible Solutions:

Remove & Replace Curb Ramp With Two New Directional Ramps or Equivalent.

Total Cost: \$ 3200.00
