# Access Compliance Report

## Public Rights-of-Way

### (Curb Ramps)

Intersection ID: 10036745	Main Street: S_GRAHAM_ST	Cross Street: N/A	Location: SW
ADA ID: 490F09C60F60	Ramp Type: BlendTrans1	Initial Pass/Fail: Fail	Overall Compliance: No
		Severity Score: 12.5

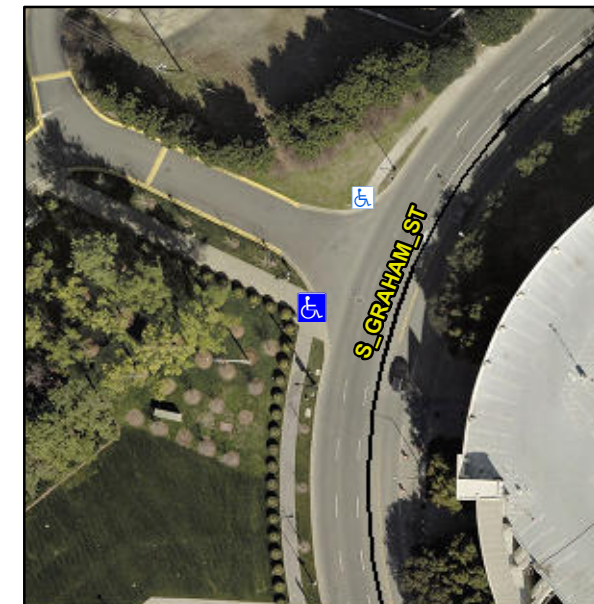
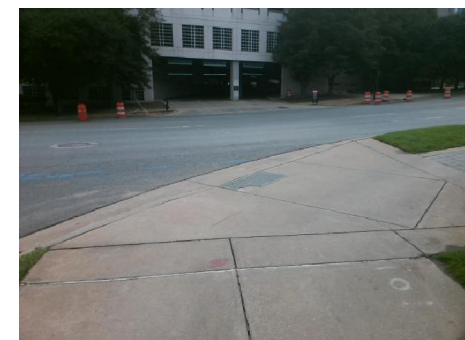
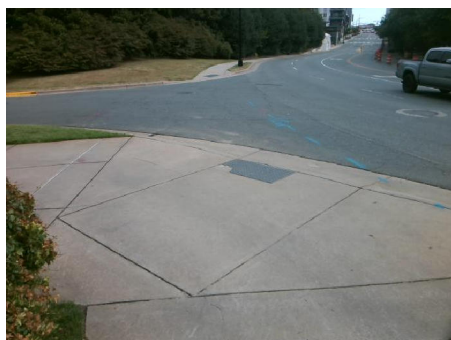
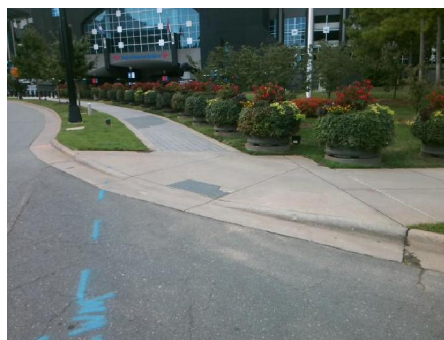
Compliance	Description	Data	Compliance	Description	Data
N/A	Ramp Length (in)	120.0	Yes	BlendTrans Slope (%)	0.0
Yes	Ramp Width (in)	89.0	No	BlendTrans XSlope (%)	5.8
N/A	Flare Type LT	N/A	N/A	Flare Type RT	N/A
N/A	Flare Slope LT (%)	N/A	N/A	Flare Slope RT (%)	N/A
N/A	Flare Traversable LT?	N/A	N/A	Flare Traversable RT?	N/A
N/A	Landing Length (in)	N/A	N/A	DWS Provided?	N/A
N/A	Landing Width (in)	N/A	N/A	DWS Contrast?	N/A
N/A	Landing Slope (%)	N/A	N/A	DWS Length (in)	N/A
N/A	Landing X Slope (%)	N/A	N/A	DWS Full Width?	N/A
N/A	Landing Curb? (Y/N)	N/A	N/A	DWS Offset (in)	N/A
N/A	Shared Landing?	N/A			
N/A	Gutter Ponding?	N/A	N/A	Gutter Slope (%)	N/A
N/A	Gutter Lip Ht (in)	N/A	N/A	Gutter X Slope (%)	N/A
N/A	Painted X Walk1?	No	N/A	Painted X Walk2?	No
	X Walk 1 Direction	To E		X Walk 2 Direction	To N
	X Walk 1 Width (in)	N/A		X Walk 2 Width (in)	N/A
	X Walk 1 Slope (%)	4.7		X Walk 2 Slope (%)	2.1
	X Walk 1 X Slope (%)	3.2		X Walk 2 X Slope (%)	1.2

N/A	Ramp inside XWalk1?	N/A	N/A	Ramp inside XWalk2?	N/A
	Road Slope (%)	3.3		Clear Space?	N/A
	Road X Slope (%)	1.4	N/A	Clear Space to XWalk (in)	N/A
N/A	Any Obstructions?	N/A	N/A	Storm Grate/Utility Hazard?	N/A
	Obstruction Type			Storm Grate/Utility Type	
		N/A			N/A
			Yes	Surface Condition? (G/P)	Good
			N/A	Curb Slope (%)	4.7

**Remove & Replace Curb Ramp With Two New Directional Ramps or Equivalent.**

**R304.5.3**
