Access Compliance Report

Public Rights-of-Way (Curb Ramps)

Intersection ID: 3901	Main Street: RHIAN_BROOK_LN	Cross Street: BEATTIES_FORD_RD	Location: S
ADA ID: 4911F9479DB8	Ramp Type: PerpDiag	Initial Pass/Fail: Fail	Overall Compliance: No
Severity Score: 15			
Codes/Mitigation Info/Possible Solution		Field Measurements/Component Compliance

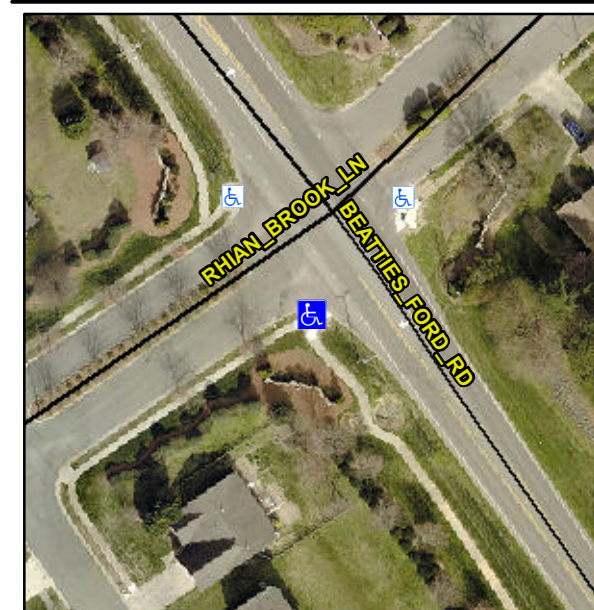
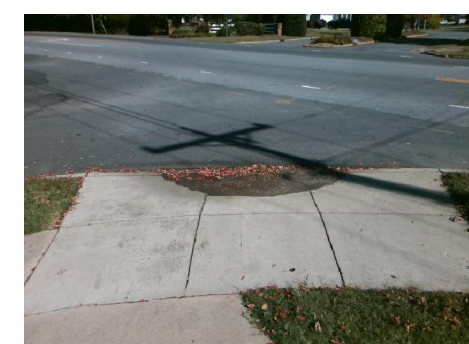
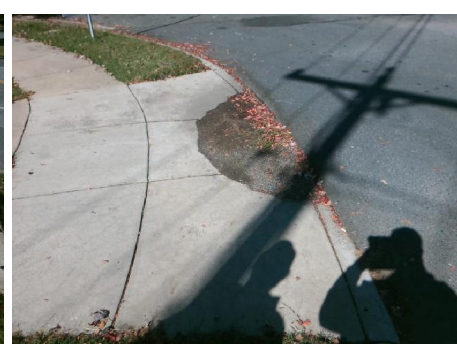
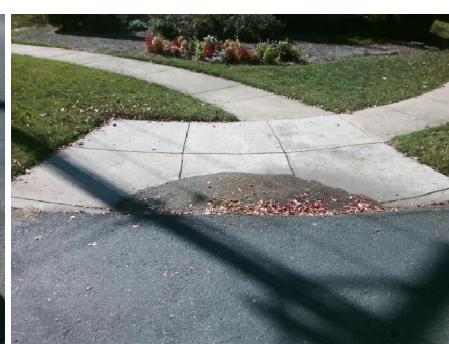
Compliance	Description	Data	Compliance	Description	Data
N/A	Ramp Length (in)	49.0	Yes	Ramp Slope (%)	5.4
Yes	Ramp Width (in)	48.0	Yes	Ramp XSlope (%)	1.6
N/A	Flare Type LT	N/A	N/A	Flare Type RT	N/A
N/A	Flare Slope LT (%)	N/A	N/A	Flare Slope RT (%)	N/A
N/A	Flare Traversable LT?	N/A	N/A	Flare Traversable RT?	N/A
N/A	Landing Length (in)	N/A	N/A	DWS Provided?	N/A
N/A	Landing Width (in)	N/A	N/A	DWS Contrast?	N/A
N/A	Landing Slope (%)	N/A	N/A	DWS Length (in)	N/A
N/A	Landing X Slope (%)	N/A	N/A	DWS Full Width?	N/A
N/A	Landing Curb? (Y/N)	N/A	N/A	DWS Offset (in)	N/A
N/A	Shared Landing?	N/A			
N/A	Gutter Ponding?	N/A	N/A	Gutter Slope (%)	N/A
N/A	Gutter Lip Ht (in)	N/A	N/A	Gutter X Slope (%)	N/A
N/A	Painted X Walk1?	No	N/A	Painted X Walk2?	No
	X Walk 1 Direction	To NE		X Walk 2 Direction	To NW
N/A	X Walk 1 Width (in)	N/A	N/A	X Walk 2 Width (in)	N/A
	X Walk 1 Slope (%)	0.3		X Walk 2 Slope (%)	2.7
	X Walk 1 X Slope (%)	1.0		X Walk 2 X Slope (%)	0.7

N/A	Ramp inside XWalk1?	N/A	N/A	Ramp inside XWalk2?	N/A
	Road Slope (%)	0.0	N/A	Clear Space?	N/A
	Road X Slope (%)	1.9	N/A	Clear Space to XWalk (in)	N/A
N/A	Any Obstructions?	N/A	N/A	Storm Grate/Utility Hazard?	N/A
	Obstruction Type			Storm Grate/Utility Type	
		N/A			N/A
		No		Surface Condition? (G/P)	Poor

Remove & Replace Curb Ramp With Two New Directional Ramps or Equivalent.

R302.7
