Access Compliance Report

Public Rights-of-Way

(Curb Ramps)

Intersection ID: 10041631	Main Street: WHITEHALL_PARK_DR	Cross Street: N/A	Location: SW
ADA ID: 491736424EE8	Ramp Type: PerpDiag	Initial Pass/Fail: Fail	Overall Compliance: No
		Severity Score: 12.5	
Codes/Mitigation Info/Possible Solution		Field Measurements/Component Compliance

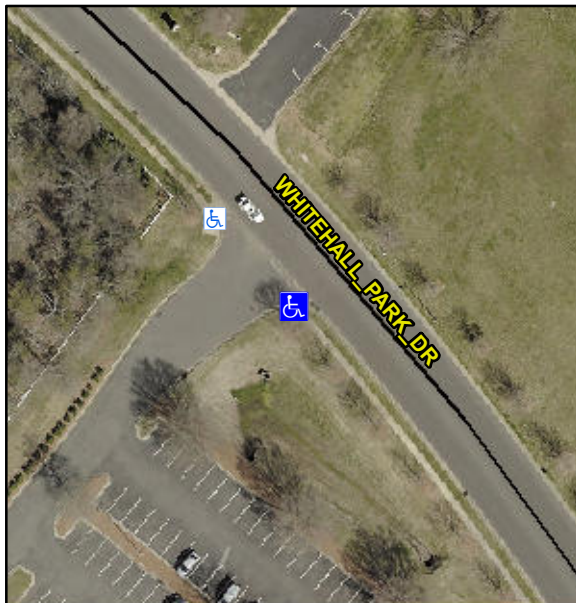
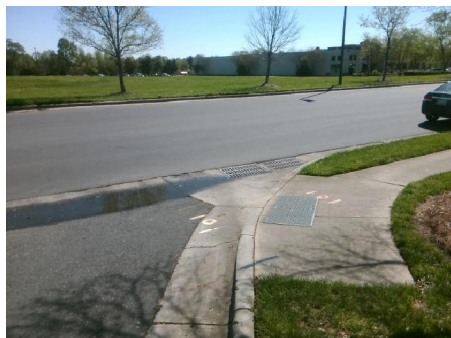
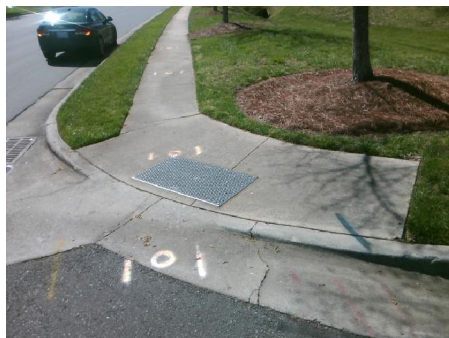
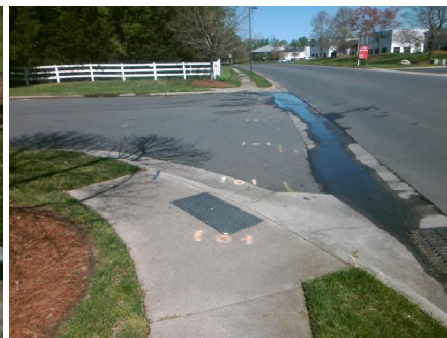
Not Found, R304.5.3

Compliance	Description	Data	Compliance	Description	Data
N/A	Ramp Length (in)	63.0	Yes	Ramp Slope (%)	5.6
Yes	Ramp Width (in)	48.0	No	Ramp XSlope (%)	5.7
N/A	Flare Type LT	N/A	N/A	Flare Type RT	N/A
N/A	Flare Slope LT (%)	N/A	N/A	Flare Slope RT (%)	N/A
N/A	Flare Traversable LT?	N/A	N/A	Flare Traversable RT?	N/A
N/A	Landing Length (in)	N/A	N/A	DWS Provided?	N/A
N/A	Landing Width (in)	N/A	N/A	DWS Contrast?	N/A
N/A	Landing Slope (%)	N/A	N/A	DWS Length (in)	N/A
N/A	Landing X Slope (%)	N/A	N/A	DWS Full Width?	N/A
N/A	Landing Curb? (Y/N)	N/A	N/A	DWS Offset (in)	N/A
N/A	Shared Landing?	N/A			
N/A	Gutter Ponding?	N/A	N/A	Gutter Slope (%)	N/A
N/A	Gutter Lip Ht (in)	N/A	N/A	Gutter X Slope (%)	N/A
N/A	Painted X Walk1?	No	N/A	Painted X Walk2?	No
	X Walk 1 Direction	To NE		X Walk 2 Direction	To NW
N/A	X Walk 1 Width (in)	N/A	N/A	X Walk 2 Width (in)	N/A
	X Walk 1 Slope (%)	2.9		X Walk 2 Slope (%)	1.0
	X Walk 1 X Slope (%)	0.4		X Walk 2 X Slope (%)	4.9

N/A	Ramp inside XWalk1?	N/A	N/A	Ramp inside XWalk2?	N/A
	Road Slope (%)	7.3	N/A	Clear Space?	N/A
	Road X Slope (%)	11.5	N/A	Clear Space to XWalk (in)	N/A
N/A	Any Obstructions?	N/A	N/A	Storm Grate/Utility Hazard?	N/A
	Obstruction Type			Storm Grate/Utility Type	
		N/A			N/A
			Yes	Surface Condition? (G/P)	Good

Remove & Replace Curb Ramp With Two New Directional Ramps or Equivalent.
