Access Compliance Report

Public Rights-of-Way

(Curb Ramps)

Intersection ID: 20587	Main Street: COLONY_RD	Cross Street: FAIRVIEW_RD	Location: SW
ADA ID: 491E0CF3A27A	Ramp Type: Perp	Initial Pass/Fail: Fail	Overall Compliance: No
		Severity Score: 10

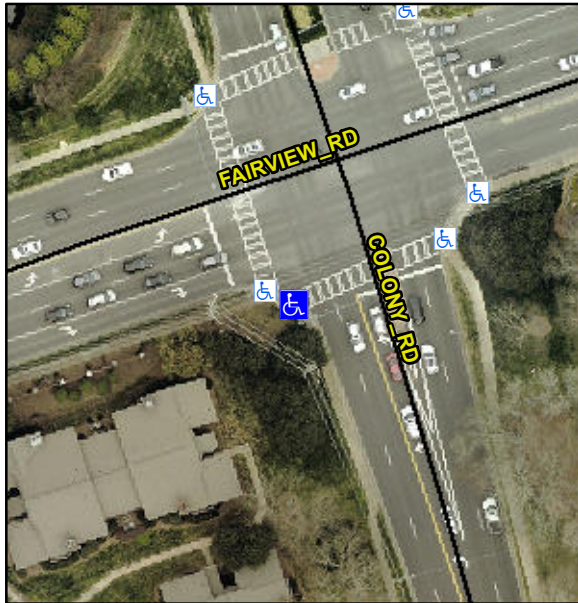
Compliance	Description	Data	Compliance	Description	Data
N/A	Ramp Length (in)	61.0	Yes	Ramp Slope (%)	5.6
No	Ramp Width (in)	43.0	No	Ramp XSlope (%)	3.4
N/A	Flare Type LT	N/A	N/A	Flare Type RT	N/A
N/A	Flare Slope LT (%)	N/A	N/A	Flare Slope RT (%)	N/A
N/A	Flare Traversable LT?	N/A	N/A	Flare Traversable RT?	N/A
N/A	Landing Length (in)	N/A	N/A	DWS Provided?	N/A
N/A	Landing Width (in)	N/A	N/A	DWS Contrast?	N/A
N/A	Landing Slope (%)	N/A	N/A	DWS Length (in)	N/A
N/A	Landing X Slope (%)	N/A	N/A	DWS Full Width?	N/A
N/A	Landing Curb? (Y/N)	N/A	N/A	DWS Offset (in)	N/A
N/A	Shared Landing?	N/A			
N/A	Gutter Ponding?	N/A	N/A	Gutter Slope (%)	N/A
N/A	Gutter Lip Ht (in)	N/A	N/A	Gutter X Slope (%)	N/A
N/A	Painted X Walk1?	Yes	N/A	Painted X Walk2?	N/A
	X Walk 1 Direction	To NE		X Walk 2 Direction	N/A
N/A	X Walk 1 Width (in)	110.0	N/A	X Walk 2 Width (in)	N/A
	X Walk 1 Slope (%)	2.8		X Walk 2 Slope (%)	N/A
	X Walk 1 X Slope (%)	1.0		X Walk 2 X Slope (%)	N/A

N/A	Ramp inside XWalk1?	Yes	N/A	Ramp inside XWalk2?	N/A
	Road Slope (%)	N/A	N/A	Clear Space?	N/A
	Road X Slope (%)	N/A	N/A	Clear Space to XWalk (in)	N/A
N/A	Any Obstructions?	N/A	N/A	Storm Grate/Utility Hazard?	N/A
	Obstruction Type			Storm Grate/Utility Type	
		N/A			N/A
			Yes	Surface Condition? (G/P)	Good

Possible Solutions:

Remove & Replace Entire Ramp.
