# Access Compliance Report

## Public Rights-of-Way

### (Curb Ramps)

Intersection ID: 50867	Main Street: REAMES_RD	Cross Street: BROOKLINE_RIDGE_DR	Location:	N
ADA ID: 49223FACD02F	Ramp Type: Perp	Initial Pass/Fail: Fail	Overall Compliance: No	Severity Score: 22.5
Codes/Mitigation Info/Possible Solution		Field Measurements/Component Compliance

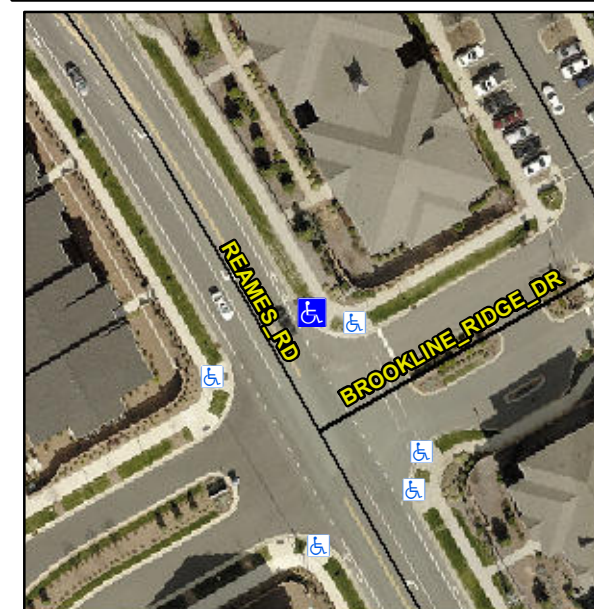
**Not Found, R304.5.1, R304.2.2, R304.5.3**

Compliance	Description	Data	Compliance	Description	Data
N/A	Ramp Length (in)	94.0	No	Ramp Slope (%)	8.5
No	Ramp Width (in)	47.0	No	Ramp XSlope (%)	2.3
N/A	Flare Type LT	N/A	N/A	Flare Type RT	N/A
N/A	Flare Slope LT (%)	N/A	N/A	Flare Slope RT (%)	N/A
N/A	Flare Traversable LT?	N/A	N/A	Flare Traversable RT?	N/A
N/A	Landing Length (in)	N/A	N/A	DWS Provided?	N/A
N/A	Landing Width (in)	N/A	N/A	DWS Contrast?	N/A
N/A	Landing Slope (%)	N/A	N/A	DWS Length (in)	N/A
N/A	Landing X Slope (%)	N/A	N/A	DWS Full Width?	N/A
N/A	Landing Curb? (Y/N)	N/A	N/A	DWS Offset (in)	N/A
N/A	Shared Landing?	N/A			
N/A	Gutter Ponding?	N/A	N/A	Gutter Slope (%)	N/A
N/A	Gutter Lip Ht (in)	N/A	N/A	Gutter X Slope (%)	N/A
N/A	Painted X Walk1?	No	N/A	Painted X Walk2?	N/A
	X Walk 1 Direction	To W		X Walk 2 Direction	N/A
N/A	X Walk 1 Width (in)	N/A	N/A	X Walk 2 Width (in)	N/A
	X Walk 1 Slope (%)	4.8		X Walk 2 Slope (%)	N/A
	X Walk 1 X Slope (%)	1.2		X Walk 2 X Slope (%)	N/A

N/A	Ramp inside XWalk1?	N/A	N/A	Ramp inside XWalk2?	N/A
	Road Slope (%)	N/A	N/A	Clear Space?	N/A
	Road X Slope (%)	N/A	N/A	Clear Space to XWalk (in)	N/A
N/A	Any Obstructions?	N/A	N/A	Storm Grate/Utility Hazard?	N/A
	Obstruction Type			Storm Grate/Utility Type	
		N/A			N/A
			Yes	Surface Condition? (G/P)	Good

**Remove & Replace Entire Ramp.**
