Access Compliance Report

Public Rights-of-Way

(Curb Ramps)

Intersection ID: 48310	Main Street: TRILLIUM_FIELDS_DR	Cross Street: GIBBON_RD	Location: SW
ADA ID: 492A297E807E	Ramp Type: Combination1	Initial Pass/Fail: Fail	Overall Compliance: No
			Severity Score: 22.5

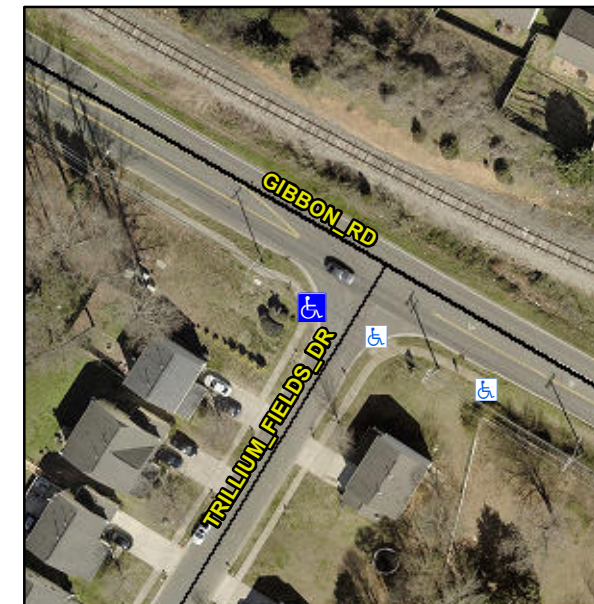
LT RP < 5%

R304.5.1, R304.2.2, R304.5.3

Compliance	Description	Data	Compliance	Description	Data
N/A	Ramp Length LT (in)	62.5	N/A	Ramp Length RT (in)	46.5
Yes	Ramp Width LT (in)	60.0	Yes	Ramp Width RT (in)	59.5
Yes	Ramp Slope LT (%)	3.4	Yes	Ramp Slope RT (%)	6.3
Yes	Ramp XSlope LT (%)	1.9	Yes	Ramp XSlope RT (%)	1.2
N/A	Ramp Length (in)	48.0	No	Ramp Slope (%)	9.1
No	Ramp Width (in)	46.5	No	Ramp XSlope (%)	3.7
N/A	Flare Type LT	N/A	N/A	Flare Type RT	N/A
N/A	Flare Slope LT (%)	N/A	N/A	Flare Slope RT (%)	N/A
N/A	Flare Traversable LT?	N/A	N/A	Flare Traversable RT?	N/A
N/A	Landing Length (in)	N/A	N/A	DWS Provided?	N/A
N/A	Landing Width (in)	N/A	N/A	DWS Contrast?	N/A
N/A	Landing Slope (%)	N/A	N/A	DWS Length (in)	N/A
N/A	Landing X Slope (%)	N/A	N/A	DWS Full Width?	N/A
N/A	Landing Curb? (Y/N)	N/A	N/A	DWS Offset (in)	N/A
N/A	Shared Landing?	N/A			
N/A	Gutter Ponding?	N/A	N/A	Gutter Slope (%)	N/A
N/A	Gutter Lip Ht (in)	N/A	N/A	Gutter X Slope (%)	N/A
N/A	Painted X Walk1?	No	N/A	Painted X Walk2?	N/A

X Walk 1 Direction	To SE		X Walk 2 Direction	N/A
	X Walk 1 Width (in)	N/A		X Walk 2 Width (in)	N/A
	X Walk 1 Slope (%)	1.4		X Walk 2 Slope (%)	N/A
	X Walk 1 X Slope (%)	4.3		X Walk 2 X Slope (%)	N/A
N/A	Ramp inside XWalk1?	N/A	N/A	Ramp inside XWalk2?	N/A
	Road Slope (%)	N/A		Clear Space?	N/A
	Road X Slope (%)	N/A	N/A	Clear Space to XWalk (in)	N/A
			N/A	Any Obstruction?	N/A
				Obstruction Type	N/A
			N/A	Storm Grate/Utility Hazard?	N/A
				Storm Grate/Utility Type	N/A
Yes	Surface Condition? (G/P)	Good			
	Curb Slope (%)	N/A

Remove & Replace Entire Ramp.
