Access Compliance Report

Public Rights-of-Way

(Curb Ramps)

Intersection ID: 14195	Main Street: CLEVELAND_AV	Cross Street: EAST_BV	Location: SW
ADA ID: 492ED1BF860A	Ramp Type: Perp	Initial Pass/Fail: Fail	Overall Compliance: No
Severity Score: 12.5			
Codes/Mitigation Info/Possible Solution		Field Measurements/Component Compliance

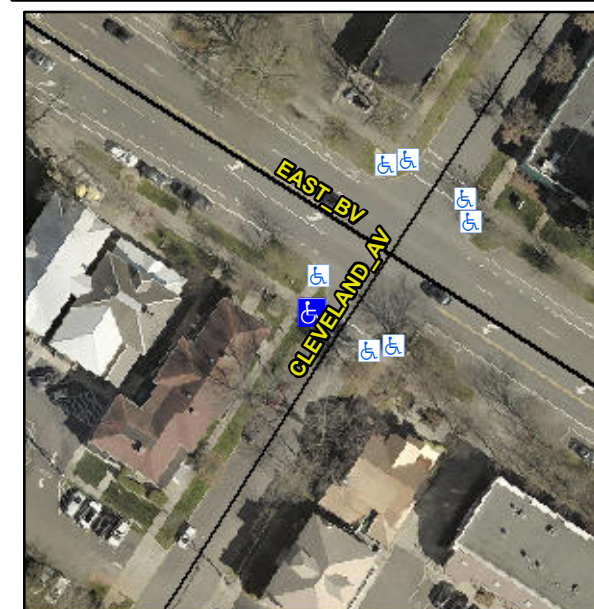
Not Found, R304.2.2

Compliance	Description	Data	Compliance	Description	Data
N/A	Ramp Length (in)	75.0	No	Ramp Slope (%)	8.9
Yes	Ramp Width (in)	72.0	Yes	Ramp XSlope (%)	1.8
N/A	Flare Type LT	N/A	N/A	Flare Type RT	N/A
N/A	Flare Slope LT (%)	N/A	N/A	Flare Slope RT (%)	N/A
N/A	Flare Traversable LT?	N/A	N/A	Flare Traversable RT?	N/A
N/A	Landing Length (in)	N/A	N/A	DWS Provided?	N/A
N/A	Landing Width (in)	N/A	N/A	DWS Contrast?	N/A
N/A	Landing Slope (%)	N/A	N/A	DWS Length (in)	N/A
N/A	Landing X Slope (%)	N/A	N/A	DWS Full Width?	N/A
N/A	Landing Curb? (Y/N)	N/A	N/A	DWS Offset (in)	N/A
N/A	Shared Landing?	N/A			
N/A	Gutter Ponding?	N/A	N/A	Gutter Slope (%)	N/A
N/A	Gutter Lip Ht (in)	N/A	N/A	Gutter X Slope (%)	N/A
N/A	Painted X Walk1?	Yes	N/A	Painted X Walk2?	N/A
	X Walk 1 Direction	To SE		X Walk 2 Direction	N/A
N/A	X Walk 1 Width (in)	110.0	N/A	X Walk 2 Width (in)	N/A
	X Walk 1 Slope (%)	2.6		X Walk 2 Slope (%)	N/A
	X Walk 1 X Slope (%)	2.4		X Walk 2 X Slope (%)	N/A

N/A	Ramp inside XWalk1?	Yes	N/A	Ramp inside XWalk2?	N/A
	Road Slope (%)	N/A	N/A	Clear Space?	N/A
	Road X Slope (%)	N/A	N/A	Clear Space to XWalk (in)	N/A
N/A	Any Obstructions?	N/A	N/A	Storm Grate/Utility Hazard?	N/A
	Obstruction Type			Storm Grate/Utility Type	
		N/A			N/A
			Yes	Surface Condition? (G/P)	Good

Remove & Replace Entire Ramp.

Total Cost: \$ 1850.00
