Access Compliance Report

Public Rights-of-Way

(Curb Ramps)

Intersection ID: 31183	Main Street: BARBEE_DR	Cross Street: FIELDSTONE_CT	Location: SE
ADA ID: 493A520CDDC3	Ramp Type: PerpDiag	Initial Pass/Fail: Fail	Overall Compliance: No
Severity Score: 10			
Codes/Mitigation Info/Possible Solution		Field Measurements/Component Compliance

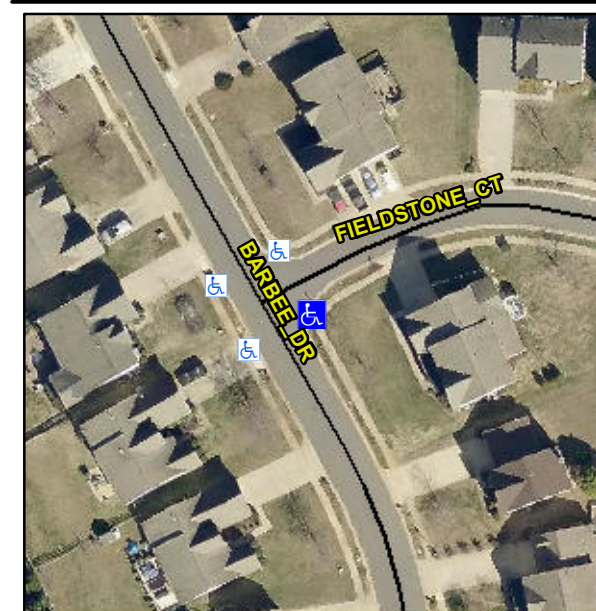
Not Found, R304.5.1, R304.5.3

Compliance	Description	Data	Compliance	Description	Data
N/A	Ramp Length (in)	49.0	Yes	Ramp Slope (%)	5.3
No	Ramp Width (in)	37.0	No	Ramp XSlope (%)	2.3
N/A	Flare Type LT	N/A	N/A	Flare Type RT	N/A
N/A	Flare Slope LT (%)	N/A	N/A	Flare Slope RT (%)	N/A
N/A	Flare Traversable LT?	N/A	N/A	Flare Traversable RT?	N/A
N/A	Landing Length (in)	N/A	N/A	DWS Provided?	N/A
N/A	Landing Width (in)	N/A	N/A	DWS Contrast?	N/A
N/A	Landing Slope (%)	N/A	N/A	DWS Length (in)	N/A
N/A	Landing X Slope (%)	N/A	N/A	DWS Full Width?	N/A
N/A	Landing Curb? (Y/N)	N/A	N/A	DWS Offset (in)	N/A
N/A	Shared Landing?	N/A			
N/A	Gutter Ponding?	N/A	N/A	Gutter Slope (%)	N/A
N/A	Gutter Lip Ht (in)	1.0	N/A	Gutter X Slope (%)	N/A
N/A	Painted X Walk1?	No	N/A	Painted X Walk2?	No
	X Walk 1 Direction	To N		X Walk 2 Direction	To W
N/A	X Walk 1 Width (in)	N/A	N/A	X Walk 2 Width (in)	N/A
	X Walk 1 Slope (%)	4.2		X Walk 2 Slope (%)	7.6
	X Walk 1 X Slope (%)	3.0		X Walk 2 X Slope (%)	3.7

N/A	Ramp inside XWalk1?	N/A	N/A	Ramp inside XWalk2?	N/A
	Road Slope (%)	0.8	N/A	Clear Space?	N/A
	Road X Slope (%)	8.0	N/A	Clear Space to XWalk (in)	N/A
N/A	Any Obstructions?	N/A	N/A	Storm Grate/Utility Hazard?	N/A
	Obstruction Type			Storm Grate/Utility Type	
		N/A			N/A
		Yes		Surface Condition? (G/P)	Good

Possible Solutions:

Remove & Replace Curb Ramp With Two New Directional Ramps or Equivalent.
