Access Compliance Report Public Rights-of-Way (Curb Ramps)

Main Street: WINTER VIEW CT Intersection ID: 46783 Cross Street: DOMINION VILLAGE DR Location: SW **Severity Score:** 12.5 ADA ID: 493DB2779809 Ramp Type: PerpDiag Initial Pass/Fail: Fail **Overall Compliance: No**

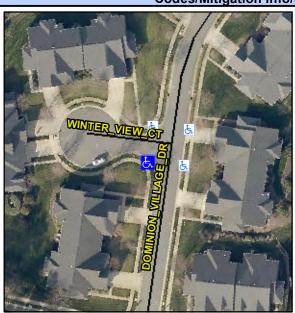
Compliance Description <u>Data</u> Compliance Description Data No N/A Ramp Length (in) 49.0 Ramp Slope (%) 10.0 Yes Ramp XSlope (%) Yes Ramp Width (in) 48.0 0.1 N/A N/A Flare Type LT N/A Flare Type RT N/A N/A N/A N/A Flare Slope RT (%) Flare Slope LT (%) N/A N/A Flare Traversable LT? N/A N/A Flare Traversable RT? N/A N/A N/A N/A **DWS Provided?** N/A Landing Length (in) N/A Landing Width (in) N/A N/A **DWS Contrast?** N/A N/A N/A Landing Slope (%) N/A DWS Length (in) N/A N/A Landing X Slope (%) N/A N/A DWS Full Width? N/A N/A Landing Curb? (Y/N) N/A N/A DWS Offset (in) N/A N/A N/A Shared Landing? N/A **Gutter Ponding?** N/A N/A Gutter Slope (%) N/A N/A Gutter Lip Ht (in) N/A N/A Gutter X Slope (%) N/A N/A Painted X Walk1? No N/A Painted X Walk2? No X Walk 1 Direction To E X Walk 2 Direction To N N/A N/A X Walk 1 Width (in) X Walk 2 Width (in) N/A X Walk 1 Slope (%) 3.6 X Walk 2 Slope (%) 1.1 X Walk 1 X Slope (%) 0.9 X Walk 2 X Slope (%) 3.3 N/A N/A N/A Ramp inside XWalk2? N/A Ramp inside XWalk1? Road Slope (%) 2.0 N/A Clear Space? N/A N/A Road X Slope (%) 2.3 Clear Space to XWalk (in) N/A N/A N/A N/A Any Obstructions? Storm Grate/Utility Hazard? N/A **Obstruction Type** Storm Grate/Utility Type N/A N/A

Street 1 Name **DOMINION VILLAGE DR** Stop Condition-Street 2 **WINTER VIEW CT** Street 2 Name Stop Condition-Street 1 StopSign Possible Solutions: Remove & Replace Curb Ramp With Two New Directional Ramps or Equivalent. Surveyor Notes: N/A PROW/ADA: Not Found, R304.2.2
