# Access Compliance Report

## Public Rights-of-Way

### (Curb Ramps)

| Intersection ID: 16896 | Main Street: BRIARCLIFF_PL | Cross Street: QUEENS_RD_WEST | Location: S |

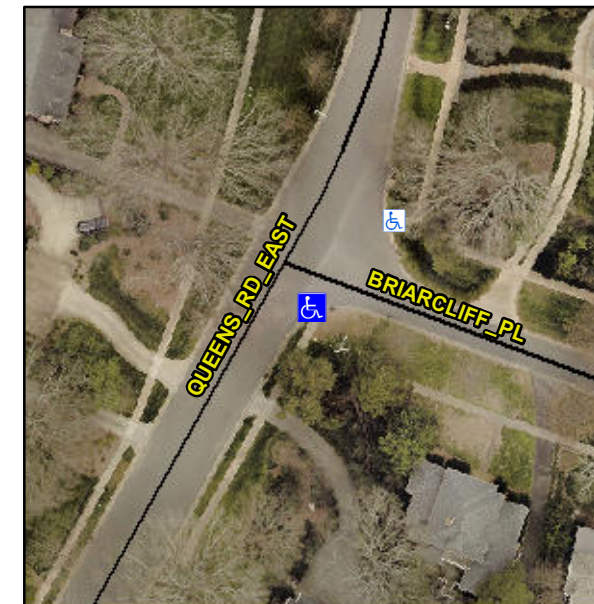
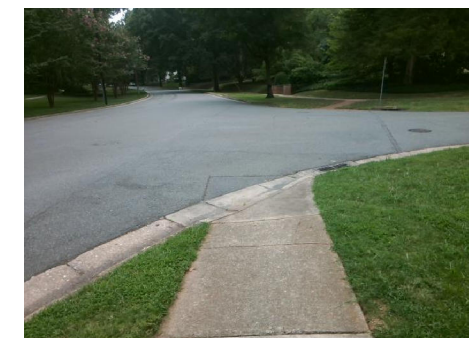
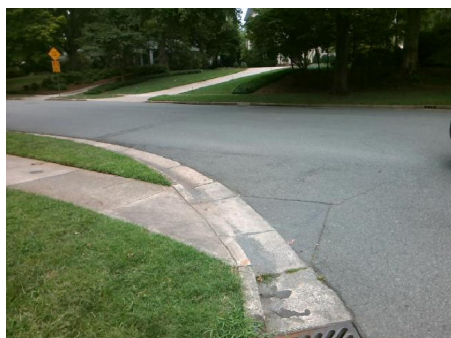
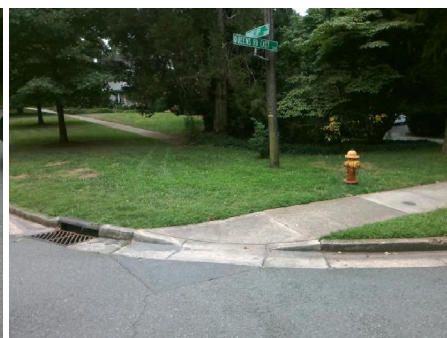
| ADA ID: 494049DC28CB | Ramp Type: PerpDiag | Initial Pass/Fail: Fail | Overall Compliance: No |
| | | Severity Score: 35 | |

**Not Found, R304.5.1, R304.2.2, R304.5.3**

| Compliance | Description | Data | Compliance | Description | Data |
|---|---|---|---|---|---|
| N/A | Ramp Length (in) | 23.0 | No | Ramp Slope (%) | 12.4 |
| No | Ramp Width (in) | 45.0 | No | Ramp XSlope (%) | 2.3 |

**Remove & Replace Curb Ramp With Two New Directional Ramps or Equivalent.**

Total Cost: \$ 3200.00
