Access Compliance Report

Public Rights-of-Way

(Curb Ramps)

Intersection ID: 10519	Main Street: HAMILTON_ST	Cross Street: POLK_ST	Location: NW
ADA ID: 495C18695646	Ramp Type: BlendTrans1	Initial Pass/Fail: Fail	Overall Compliance: No
		Severity Score: 8.75

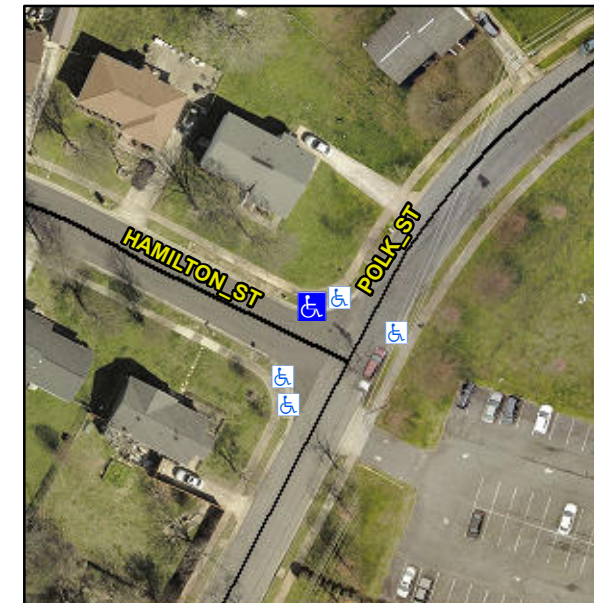
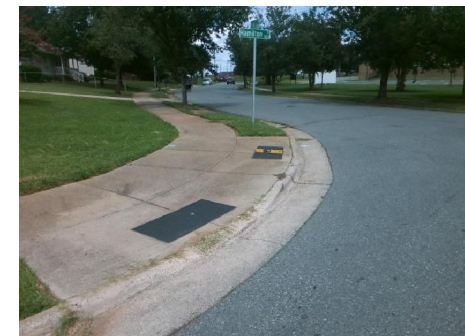
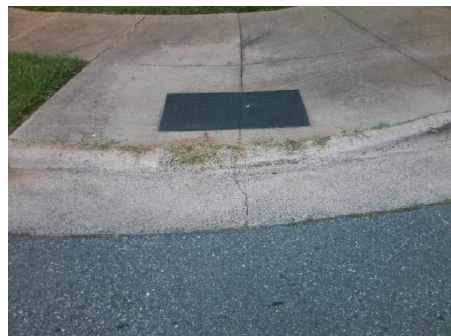
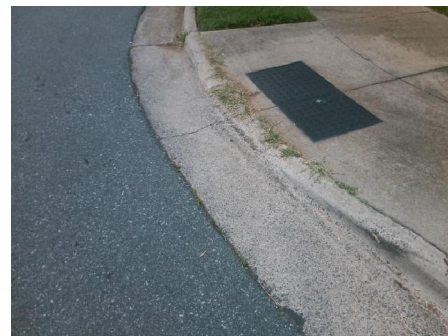
Not Found, R304.5.1

Compliance	Description	Data	Compliance	Description	Data
N/A	Ramp Length (in)	56.0	Yes	BlendTrans Slope (%)	3.4
No	Ramp Width (in)	43.0	Yes	BlendTrans XSlope (%)	0.7
N/A	Flare Type LT	N/A	N/A	Flare Type RT	N/A
N/A	Flare Slope LT (%)	N/A	N/A	Flare Slope RT (%)	N/A
N/A	Flare Traversable LT?	N/A	N/A	Flare Traversable RT?	N/A
N/A	Landing Length (in)	N/A	N/A	DWS Provided?	N/A
N/A	Landing Width (in)	N/A	N/A	DWS Contrast?	N/A
N/A	Landing Slope (%)	N/A	N/A	DWS Length (in)	N/A
N/A	Landing X Slope (%)	N/A	N/A	DWS Full Width?	N/A
N/A	Landing Curb? (Y/N)	N/A	N/A	DWS Offset (in)	N/A
N/A	Shared Landing?	N/A			
N/A	Gutter Ponding?	N/A	N/A	Gutter Slope (%)	N/A
N/A	Gutter Lip Ht (in)	N/A	N/A	Gutter X Slope (%)	N/A
N/A	Painted X Walk1?	No	N/A	Painted X Walk2?	N/A
	X Walk 1 Direction	To SW		X Walk 2 Direction	N/A
	X Walk 1 Width (in)	N/A		X Walk 2 Width (in)	N/A
	X Walk 1 Slope (%)	0.6		X Walk 2 Slope (%)	N/A
	X Walk 1 X Slope (%)	3.9		X Walk 2 X Slope (%)	N/A

N/A	Ramp inside XWalk1?	N/A	N/A	Ramp inside XWalk2?	N/A
	Road Slope (%)	3.9		Clear Space?	N/A
	Road X Slope (%)	0.6	N/A	Clear Space to XWalk (in)	N/A
N/A	Any Obstructions?	N/A	N/A	Storm Grate/Utility Hazard?	N/A
	Obstruction Type			Storm Grate/Utility Type	
		N/A			N/A
			Yes	Surface Condition? (G/P)	Good
			No	Curb Slope (%)	27.1

Remove & Replace Curb Ramp With Two New Directional Ramps or Equivalent.

Total Cost: \$ 3200.00
