Access Compliance Report

Public Rights-of-Way

(Curb Ramps)

Intersection ID: 27262	Main Street: BLOOMFIELD_DR	Cross Street: ROSELAND_AV	Location: NE
ADA ID: 4964E31DB3B6	Ramp Type: PerpDiag	Initial Pass/Fail: Fail	Overall Compliance: No
		Severity Score: 25

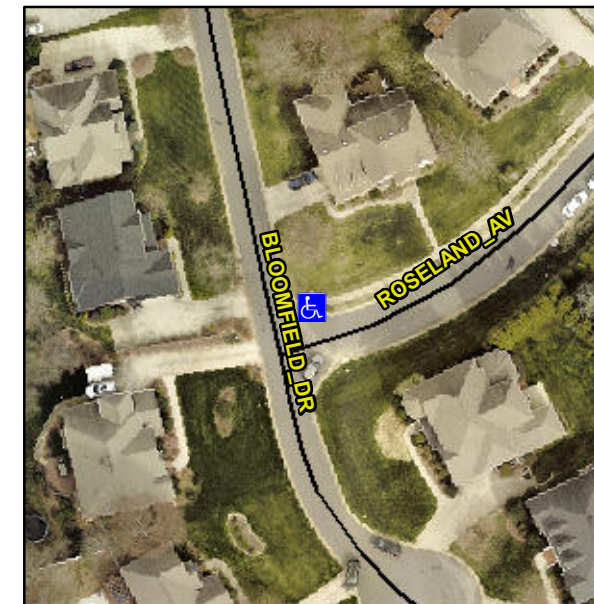
Not Found, R304.5.3

Compliance	Description	Data	Compliance	Description	Data
N/A	Ramp Length (in)	47.0	Yes	Ramp Slope (%)	5.8
Yes	Ramp Width (in)	48.0	No	Ramp XSlope (%)	9.0
N/A	Flare Type LT	N/A	N/A	Flare Type RT	N/A
N/A	Flare Slope LT (%)	N/A	N/A	Flare Slope RT (%)	N/A
N/A	Flare Traversable LT?	N/A	N/A	Flare Traversable RT?	N/A
N/A	Landing Length (in)	N/A	N/A	DWS Provided?	N/A
N/A	Landing Width (in)	N/A	N/A	DWS Contrast?	N/A
N/A	Landing Slope (%)	N/A	N/A	DWS Length (in)	N/A
N/A	Landing X Slope (%)	N/A	N/A	DWS Full Width?	N/A
N/A	Landing Curb? (Y/N)	N/A	N/A	DWS Offset (in)	N/A
N/A	Shared Landing?	N/A			
N/A	Gutter Ponding?	N/A	N/A	Gutter Slope (%)	N/A
N/A	Gutter Lip Ht (in)	N/A	N/A	Gutter X Slope (%)	N/A
N/A	Painted X Walk1?	No	N/A	Painted X Walk2?	No
	X Walk 1 Direction	To W		X Walk 2 Direction	To S
N/A	X Walk 1 Width (in)	N/A	N/A	X Walk 2 Width (in)	N/A
	X Walk 1 Slope (%)	0.8		X Walk 2 Slope (%)	5.4
	X Walk 1 X Slope (%)	6.5		X Walk 2 X Slope (%)	4.6

N/A	Ramp inside XWalk1?	N/A	N/A	Ramp inside XWalk2?	N/A
	Road Slope (%)	6.5	N/A	Clear Space?	N/A
	Road X Slope (%)	6.2	N/A	Clear Space to XWalk (in)	N/A
N/A	Any Obstructions?	N/A	N/A	Storm Grate/Utility Hazard?	N/A
	Obstruction Type			Storm Grate/Utility Type	
		N/A			N/A
		Yes		Surface Condition? (G/P)	Good

Remove & Replace Curb Ramp With Two New Directional Ramps or Equivalent.
