Access Compliance Report

Public Rights-of-Way

(Curb Ramps)

Intersection ID: 15195	Main Street: ALBEMARLE_RD	Cross Street: FARM_POND_LN	Location: NW
ADA ID: 49720E0972D3	Ramp Type: Perp	Initial Pass/Fail: Fail	Overall Compliance: No Severity Score: 36.25

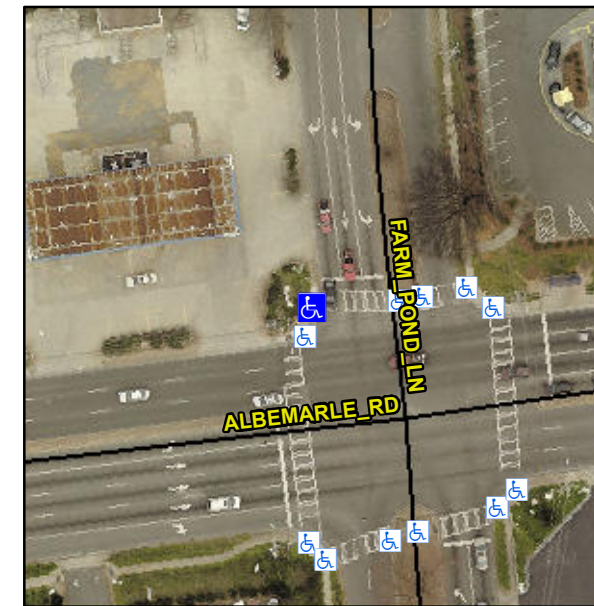
Not Found, R304.5.1, R304.2.2, R302.7

Compliance	Description	Data	Compliance	Description	Data
N/A	Ramp Length (in)	50.0	No	Ramp Slope (%)	10.6
No	Ramp Width (in)	45.0	Yes	Ramp XSlope (%)	1.7
N/A	Flare Type LT	N/A	N/A	Flare Type RT	N/A
N/A	Flare Slope LT (%)	N/A	N/A	Flare Slope RT (%)	N/A
N/A	Flare Traversable LT?	N/A	N/A	Flare Traversable RT?	N/A
N/A	Landing Length (in)	N/A	N/A	DWS Provided?	N/A
N/A	Landing Width (in)	N/A	N/A	DWS Contrast?	N/A
N/A	Landing Slope (%)	N/A	N/A	DWS Length (in)	N/A
N/A	Landing X Slope (%)	N/A	N/A	DWS Full Width?	N/A
N/A	Landing Curb? (Y/N)	N/A	N/A	DWS Offset (in)	N/A
N/A	Shared Landing?	N/A			
N/A	Gutter Ponding?	N/A	N/A	Gutter Slope (%)	N/A
N/A	Gutter Lip Ht (in)	N/A	N/A	Gutter X Slope (%)	N/A
N/A	Painted X Walk1?	Yes	N/A	Painted X Walk2?	N/A
	X Walk 1 Direction	To E		X Walk 2 Direction	N/A
N/A	X Walk 1 Width (in)	112.0	N/A	X Walk 2 Width (in)	N/A
	X Walk 1 Slope (%)	4.4		X Walk 2 Slope (%)	N/A
	X Walk 1 X Slope (%)	1.2		X Walk 2 X Slope (%)	N/A

N/A	Ramp inside XWalk1?	Yes	N/A	Ramp inside XWalk2?	N/A
	Road Slope (%)	N/A	N/A	Clear Space?	N/A
	Road X Slope (%)	N/A	N/A	Clear Space to XWalk (in)	N/A
N/A	Any Obstructions?	N/A	N/A	Storm Grate/Utility Hazard?	N/A
	Obstruction Type			Storm Grate/Utility Type	
		N/A			N/A
		No		Surface Condition? (G/P)	Poor

Remove & Replace Entire Ramp.
