# Access Compliance Report

## Public Rights-of-Way

### (Curb Ramps)

| Intersection ID: N/A | Main Street: PERIMETER_POINTE_PY | Cross Street: GLEN_LAKE_DR | Location: SE |

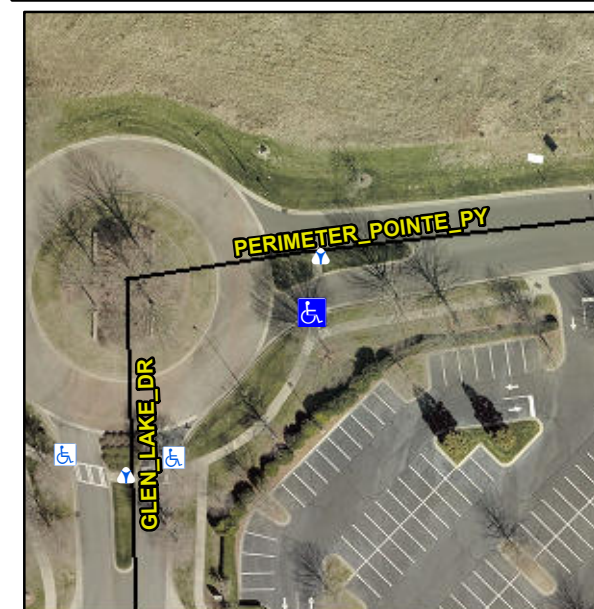
**R304.5.3, R305.2**

| Compliance | Description | Data | Compliance | Description | Data |
|---|---|---|---|---|---|
| Yes | Ramp Slope (%) | 5.9 | No | Grade Break XSlope (%) | 4.0 |
| No | Ramp XSlope (%) | 3.9 | | | |
| N/A | Shared Landing? | No | No | DWS Offset RT (in) | 3.0 |
| Yes | Gutter Lip Ht (in) | 0.0 | No | Gutter X Slope (%) | 3.8 |

**Remove & Replace Entire Ramp.  
Remove & Replace Gutter.**
