Access Compliance Report

Public Rights-of-Way

(Curb Ramps)

Intersection ID: 28132	Main Street: LAHINCH_CT	Cross Street: PORTMARNOCK_CT	Location: SE
ADA ID: 498145286D5A	Ramp Type: PerpDiag	Initial Pass/Fail: Pass	Overall Compliance: No
			Severity Score: 30.25

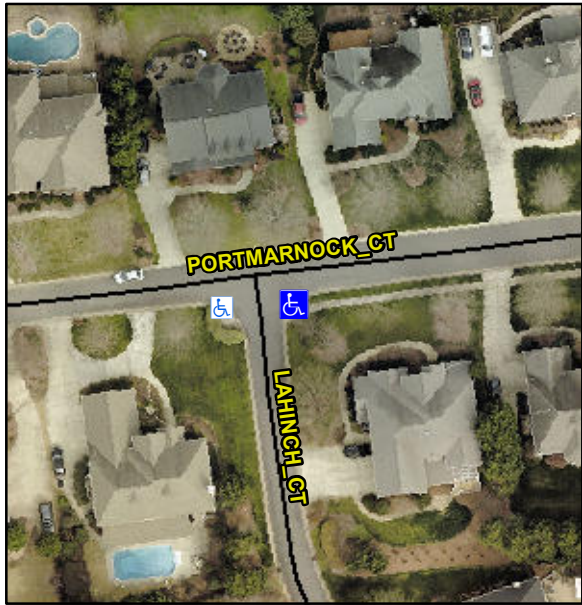
Possible Solutions:		Compliance	Description	Data	Compliance	Description	Data
	Remove & Replace Curb Ramp With Two New Directional Ramps or Equivalent. Remove & Replace Gutter.		N/A	Ramp Length (in)	49.5	Yes	Ramp Slope (%)	5.2
			Yes	Ramp Width (in)	123.0	No	Ramp XSlope (%)	2.9
			N/A	Flare Type LT	Sloped	N/A	Flare Type RT	N/A
			N/A	Flare Slope LT (%)	2.3	N/A	Flare Slope RT (%)	N/A
			N/A	Flare Traversable LT?	No	N/A	Flare Traversable RT?	No
			Yes	Landing Length (in)	49.0	No	DWS Provided?	No
			Yes	Landing Width (in)	72.0	N/A	DWS Contrast?	No
			No	Landing Slope (%)	4.5	N/A	DWS Length (in)	N/A
			No	Landing X Slope (%)	3.5	N/A	DWS Full Width?	No
		N/A	Landing Curb? (Y/N)	No	N/A	DWS Offset (in)	N/A	
		N/A	Shared Landing?	No				
		Yes	Gutter Ponding?	No	No	Gutter Slope (%)		9.9
		No	Gutter Lip Ht (in)	1.5	Yes	Gutter X Slope (%)		1.8

N/A	Painted X Walk1?	No	N/A	Painted X Walk2?		No
			X Walk 1 Direction	To N		X Walk 2 Direction		To W
		N/A	X Walk 1 Width (in)	N/A	N/A	X Walk 2 Width (in)		N/A
			X Walk 1 Slope (%)	4.6		X Walk 2 Slope (%)		2.7
			X Walk 1 X Slope (%)	0.7		X Walk 2 X Slope (%)		4.9
		N/A	Ramp inside XWalk1?	N/A	N/A	Ramp inside XWalk2?		N/A
			Road Slope (%)	5.3	N/A	Clear Space?		Yes
			Road X Slope (%)	8.3	N/A	Clear Space to XWalk (in)		N/A
		Yes	Any Obstructions?	No	Yes	Storm Grate/Utility Hazard?		No
			Obstruction Type			Storm Grate/Utility Type		
				N/A				N/A
					Yes	Surface Condition? (G/P)		Good
