Access Compliance Report

Public Rights-of-Way

(Curb Ramps)

Intersection ID: 27855	Main Street: LUNDIN_LINKS_LN	Cross Street: PINE_VALLEY_CLUB_DR	Location: NW
ADA ID: 49876A7F84BC	Ramp Type: Perp	Initial Pass/Fail: Fail	Overall Compliance: No Severity Score: 33.75
Codes/Mitigation Info/Possible Solution		Field Measurements/Component Compliance

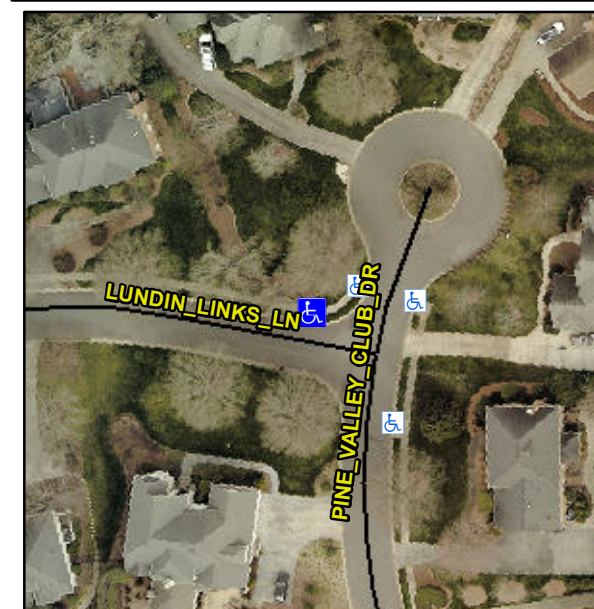
Not Found, R304.5.1, R304.2.2

Compliance	Description	Data	Compliance	Description	Data
N/A	Ramp Length (in)	46.0	No	Ramp Slope (%)	12.5
No	Ramp Width (in)	43.0	Yes	Ramp XSlope (%)	1.1
N/A	Flare Type LT	N/A	N/A	Flare Type RT	N/A
N/A	Flare Slope LT (%)	N/A	N/A	Flare Slope RT (%)	N/A
N/A	Flare Traversable LT?	N/A	N/A	Flare Traversable RT?	N/A
N/A	Landing Length (in)	N/A	N/A	DWS Provided?	N/A
N/A	Landing Width (in)	N/A	N/A	DWS Contrast?	N/A
N/A	Landing Slope (%)	N/A	N/A	DWS Length (in)	N/A
N/A	Landing X Slope (%)	N/A	N/A	DWS Full Width?	N/A
N/A	Landing Curb? (Y/N)	N/A	N/A	DWS Offset (in)	N/A
N/A	Shared Landing?	N/A			
N/A	Gutter Ponding?	N/A	N/A	Gutter Slope (%)	N/A
N/A	Gutter Lip Ht (in)	N/A	N/A	Gutter X Slope (%)	N/A
N/A	Painted X Walk1?	No	N/A	Painted X Walk2?	N/A
	X Walk 1 Direction	To SE		X Walk 2 Direction	N/A
N/A	X Walk 1 Width (in)	N/A	N/A	X Walk 2 Width (in)	N/A
	X Walk 1 Slope (%)	5.8		X Walk 2 Slope (%)	N/A
	X Walk 1 X Slope (%)	1.1		X Walk 2 X Slope (%)	N/A

N/A	Ramp inside XWalk1?	N/A	N/A	Ramp inside XWalk2?	N/A
	Road Slope (%)	N/A	N/A	Clear Space?	N/A
	Road X Slope (%)	N/A	N/A	Clear Space to XWalk (in)	N/A
N/A	Any Obstructions?	N/A	N/A	Storm Grate/Utility Hazard?	N/A
	Obstruction Type			Storm Grate/Utility Type	
		N/A			N/A
			Yes	Surface Condition? (G/P)	Good

Remove & Replace Entire Ramp.

Total Cost: \$ 1850.00
