# Access Compliance Report

## Public Rights-of-Way

### (Curb Ramps)

Intersection ID: 50594	Main Street: BEAR_GRASS_LN	Cross Street: GRAY_WILLOW_RD	Location:	N
ADA ID: 498818989099	Ramp Type: Perp	Initial Pass/Fail: Fail	Overall Compliance: No	Severity Score: 10
Codes/Mitigation Info/Possible Solution		Field Measurements/Component Compliance

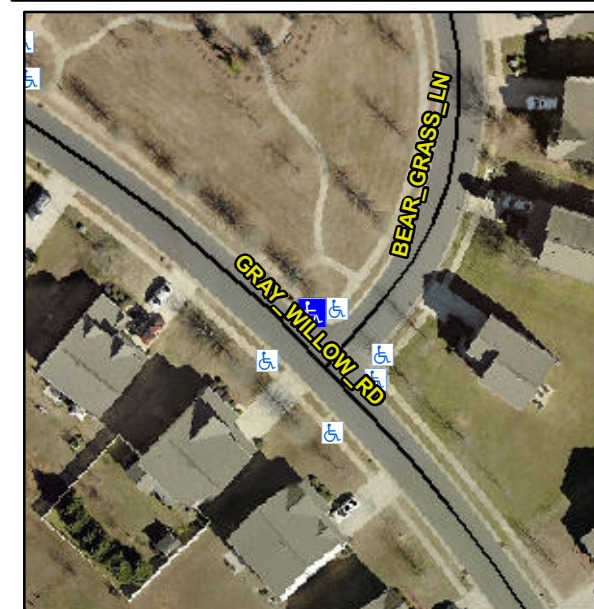
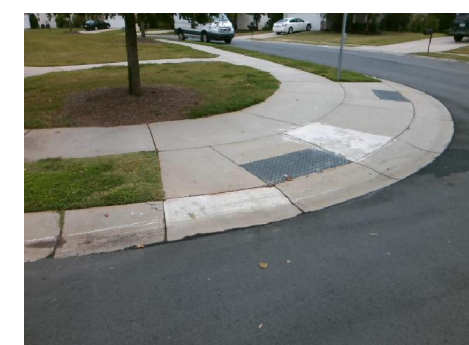
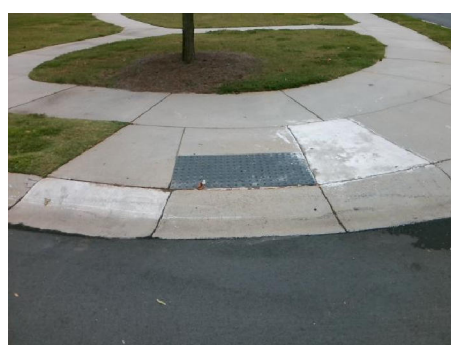
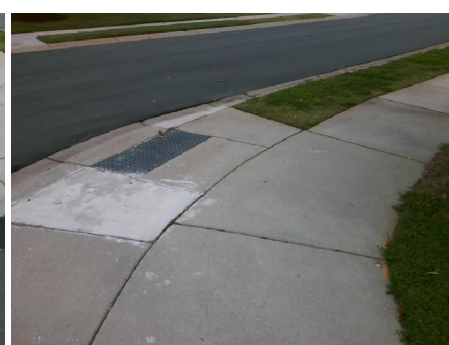
**Not Found, R304.5.1, R304.5.3**

Compliance	Description	Data	Compliance	Description	Data
N/A	Ramp Length (in)	53.0	Yes	Ramp Slope (%)	5.1
No	Ramp Width (in)	46.5	No	Ramp XSlope (%)	2.5
N/A	Flare Type LT	N/A	N/A	Flare Type RT	N/A
N/A	Flare Slope LT (%)	N/A	N/A	Flare Slope RT (%)	N/A
N/A	Flare Traversable LT?	N/A	N/A	Flare Traversable RT?	N/A
N/A	Landing Length (in)	N/A	N/A	DWS Provided?	N/A
N/A	Landing Width (in)	N/A	N/A	DWS Contrast?	N/A
N/A	Landing Slope (%)	N/A	N/A	DWS Length (in)	N/A
N/A	Landing X Slope (%)	N/A	N/A	DWS Full Width?	N/A
N/A	Landing Curb? (Y/N)	N/A	N/A	DWS Offset (in)	N/A
N/A	Shared Landing?	N/A			
N/A	Gutter Ponding?	N/A	N/A	Gutter Slope (%)	N/A
N/A	Gutter Lip Ht (in)	N/A	N/A	Gutter X Slope (%)	N/A
N/A	Painted X Walk1?	No	N/A	Painted X Walk2?	N/A
	X Walk 1 Direction	To SW		X Walk 2 Direction	N/A
N/A	X Walk 1 Width (in)	N/A	N/A	X Walk 2 Width (in)	N/A
	X Walk 1 Slope (%)	2.6		X Walk 2 Slope (%)	N/A
	X Walk 1 X Slope (%)	2.4		X Walk 2 X Slope (%)	N/A

N/A	Ramp inside XWalk1?	N/A	N/A	Ramp inside XWalk2?	N/A
	Road Slope (%)	N/A	N/A	Clear Space?	N/A
	Road X Slope (%)	N/A	N/A	Clear Space to XWalk (in)	N/A
N/A	Any Obstructions?	N/A	N/A	Storm Grate/Utility Hazard?	N/A
	Obstruction Type			Storm Grate/Utility Type	
		N/A			N/A
			Yes	Surface Condition? (G/P)	Good

**Remove & Replace Entire Ramp.**
